Product Safety Recall

18269 Mechanical Key Ignition Switch

Reference Number: N182186060

Release Date: October 2018

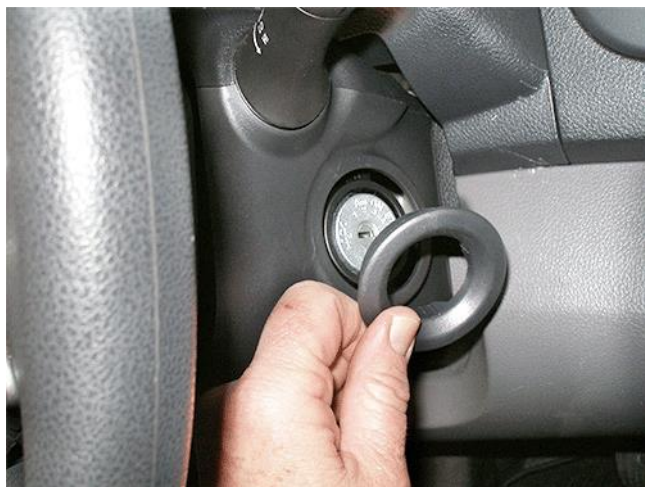
5143059

6. Remove the ignition switch bezel.
7. Remove the steering column cover screws.

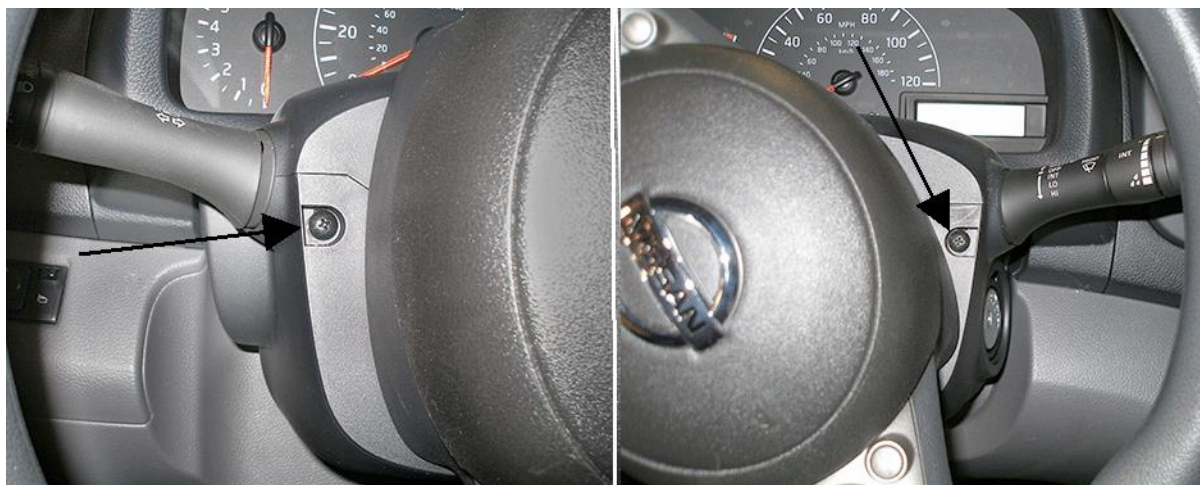
5143060

8. Rotate the steering wheel to access steering column cover screws.
9. Remove the steering column covers:
 - 9.1. Tilt the steering column to the lowest position.

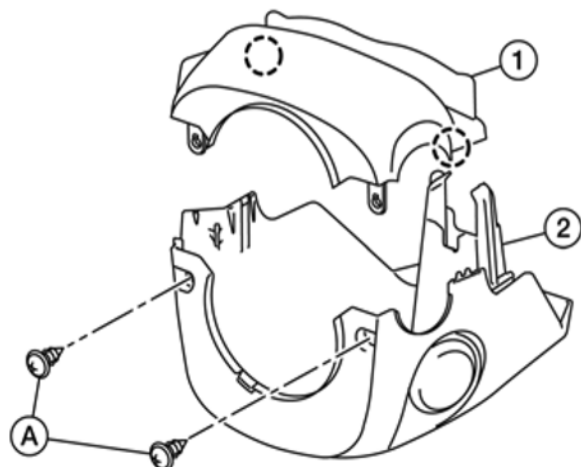
5143072

- 9.2. Pull the steering column upper cover (1) upward to release steering column upper cover pawls from the steering column lower cover (2).

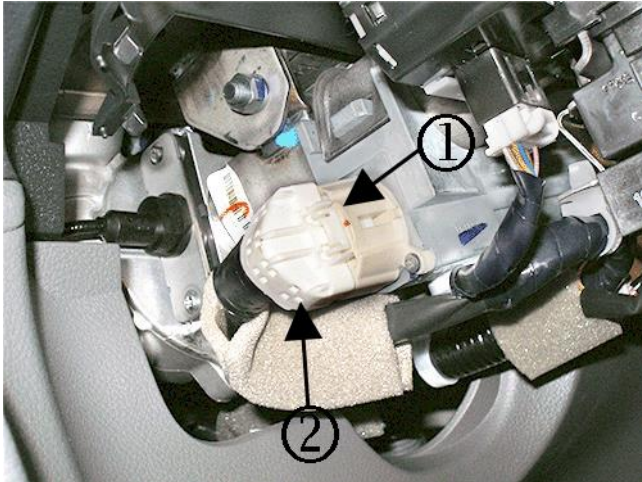
5143074

11. Depress the tab on the ignition switch harness connector (1) to release it from the ignition switch (2).

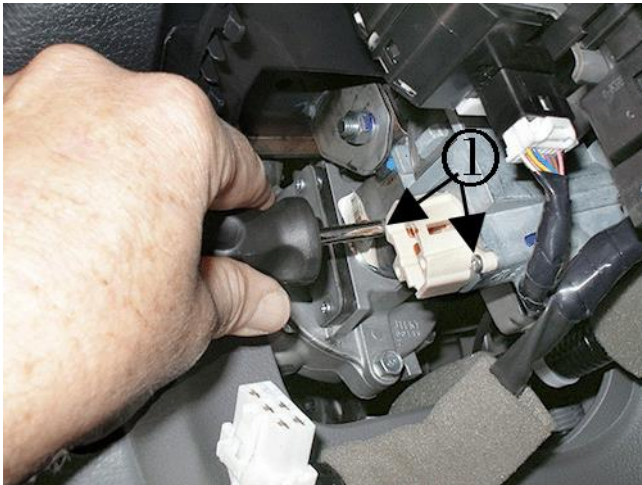
5143075

12. Remove the 2 ignition switch screws (1).

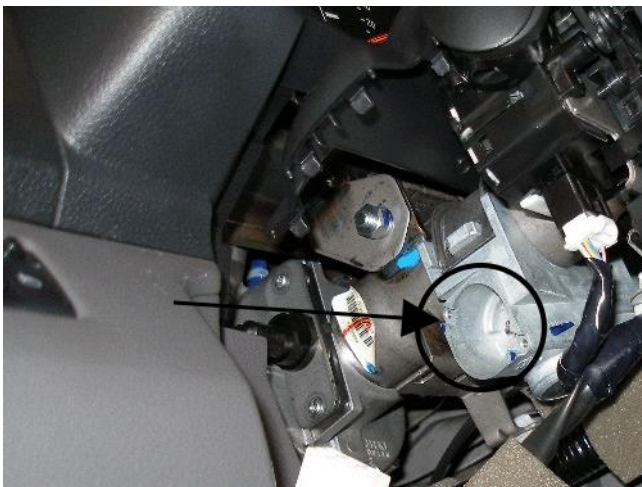
5143077

Note: the picture above shows the ignition switch already removed.

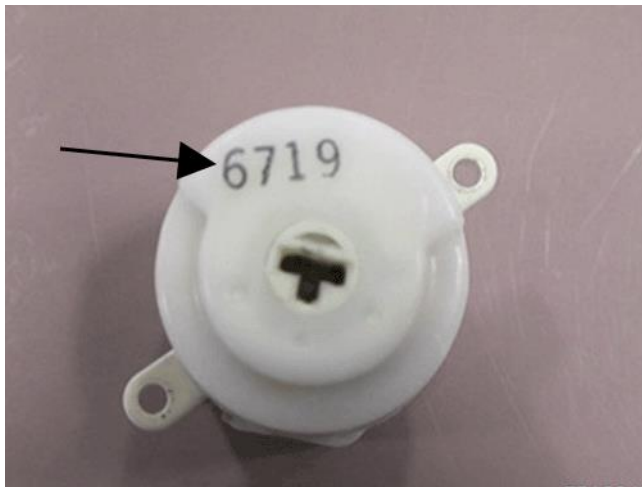
5143078

14. Record the lot number located on the back side of the ignition switch.

Note: Lot number shown above is an example only. The lot number on the switch removed may be different.

15. Inspect the ignition switch lot number using the table above.

- If the ignition switch has one of the lot numbers listed, the ignition switch must be replaced. Replace the ignition switch and proceed to step 16.
- If the ignition switch DOES NOT have one of the lot numbers listed above, no further action required. Do not replace the ignition switch. Proceed to step 16.
