**TO:** All U.S. Ford and Lincoln Dealers  
**SUBJECT: NEW VEHICLE DEMONSTRATION / DELIVERY HOLD -  
Safety Recall 18S27**  
Certain 2015 through 2018 Model Year F-150 Regular Cab and SuperCrew Cab  
Vehicles  
Carpet Shielding and Insulation Rework

**NEW VEHICLE DEMONSTRATION / DELIVERY HOLD –****Safety Recall 18S27**

## CERTAIN 2015 THROUGH 2018 MODEL YEAR F-150 REGULAR CAB AND SUPERCREW CAB VEHICLES — CARPET SHIELDING AND INSULATION REWORK

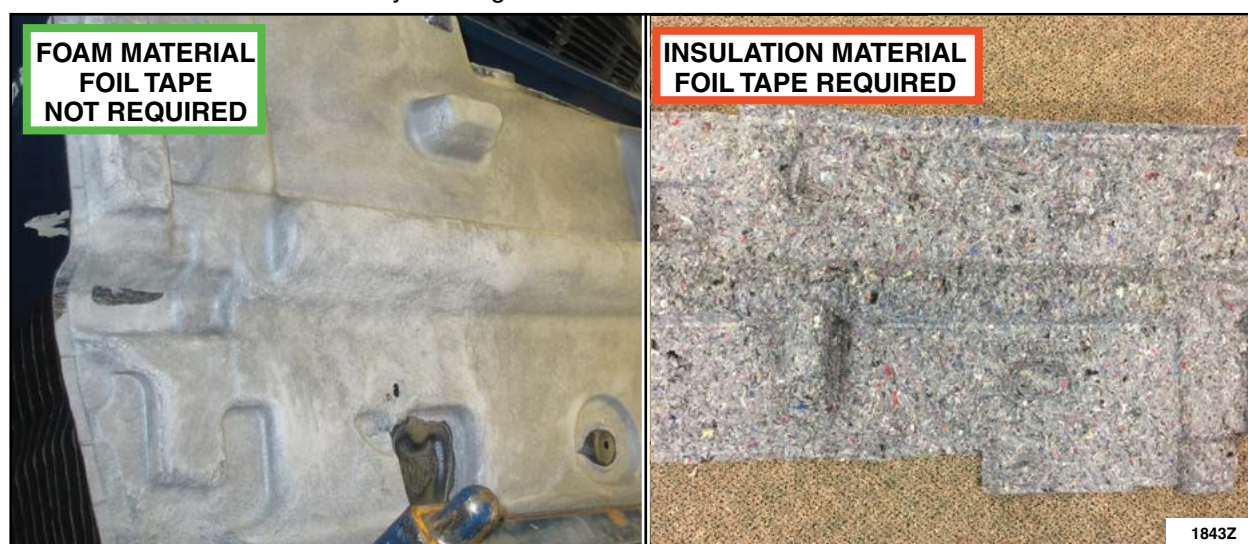
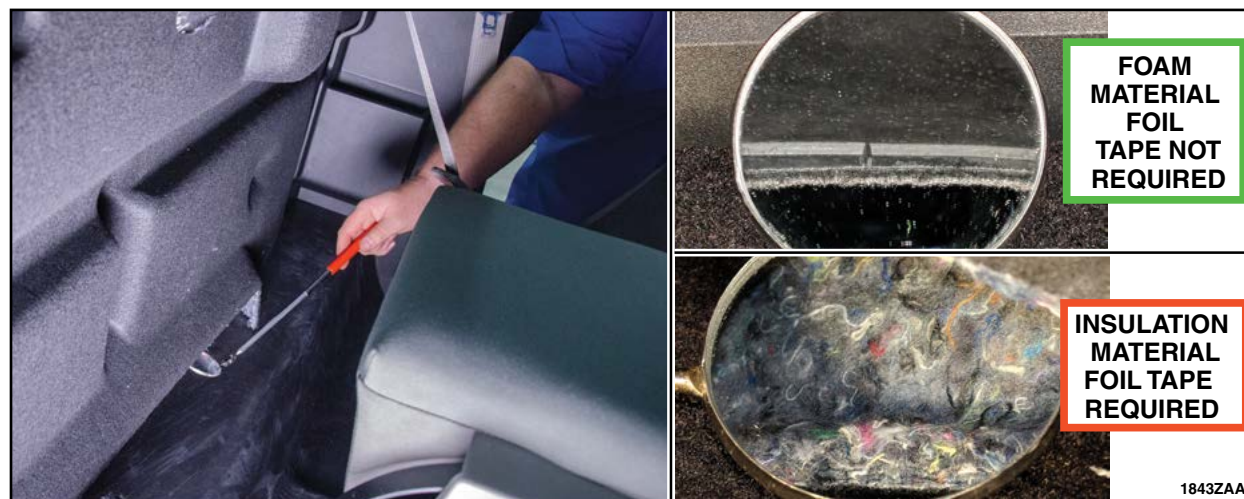
**NOTE:** Vehicles built from the beginning of 2015 through mid July 2018 will be equipped with loadspace trim panels backed with insulation material similar to floor carpet insulation. Vehicles built after mid July 2018 are equipped with loadspace trim panels backed with a foam material.

1. Using an inspection mirror inspect the loadspace trim panel backside for either insulation type material or molded foam material. See Figures 8a and 8b.
  - If the loadspace trim panel has insulation material, foil tape will need to be installed, proceed to "Loadspace Trim Panel Foil Tape Installation" on Page 8.
  - If the loadspace trim panel has molded foam material, proceed to "B-Pillar Insulation Removal and Vehicle Reassembly" on Page 16.
