2010 – 2014 model year Legacy and Outback M/T vehicles
Electronic Parking Brake Actuator Recall
Bulletin: WTV-81

3/21/19 Updated Talking Points:

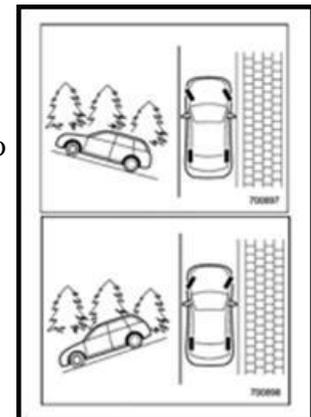
Apply the electronic parking brake (EPB) by depressing the brake pedal and pressing the parking brake switch firmly.

To release the EPB, pull the parking brake switch toward you while the ignition switch is in the ON position with both the brake pedal and clutch pedal depressed.
