Subaru Announcement

UPDATE Subaru Safety Recall: WTV-81 EPB Actuator Assembly

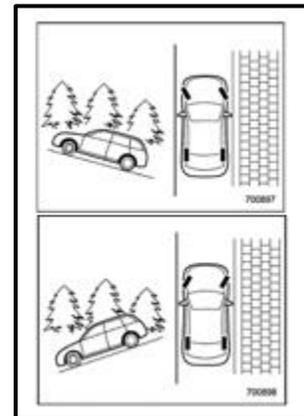
- Whenever possible, park the vehicle in a flat location.
- When parking uphill, the front wheels should be turned away from the curb as shown. Also, be sure to shift the M/T shifter into first gear when parking uphill.
- When parking downhill, the front wheels should be turned into the curb as shown. Also, be sure to shift the M/T shift lever into reverse gear when parking the vehicle downhill.
- Apply the electronic parking brake (EPB) by depressing the brake pedal and pressing the parking brake switch firmly.
