Safety Recall Campaign 4009
SC-77

November 2, 2018

Safety Recall Campaign 4009 Power Steering Tensioner Pulley

Affected Models: Certain 2006 Grand Vitara Models

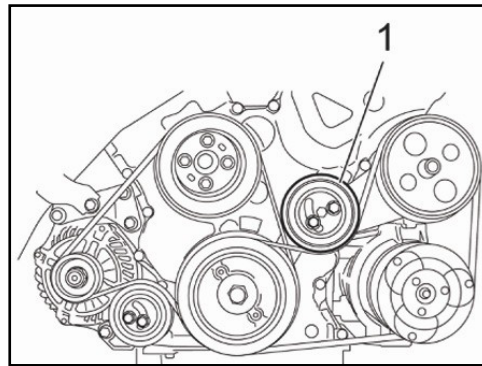
- 2) Visually check the tensioner pulley (1) outer race to determine if it is plastic or steel.

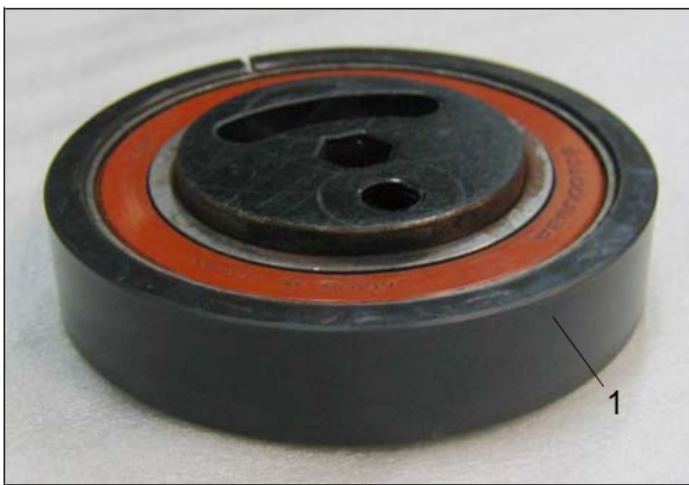
- 3) You can easily identify if it is plastic or steel by the color of the outer race.

Black: Plastic Outer Race (1)
Replace

- 4) Remove the plastic tensioner pulley (1) from the engine:

Loosen the tensioner pulley adjusting bolt (2) to relieve the tension on the power steering/AC belt, and remove it along with the tensioner pulley bolt (3). Then remove the tensioner pulley.

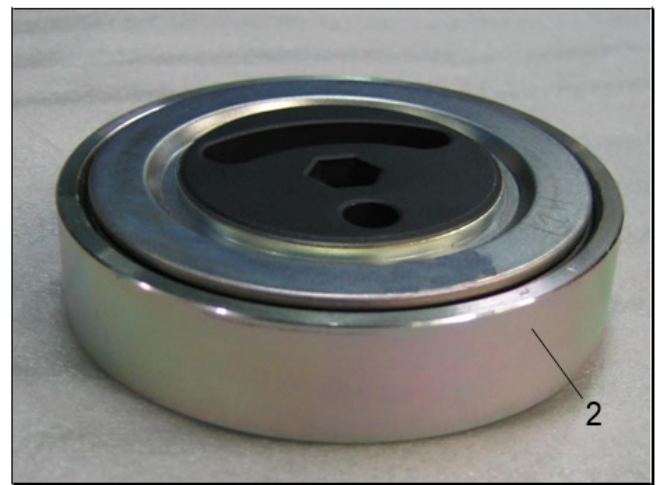
Silver: Smooth Steel Outer Race (2)
Do Not Replace

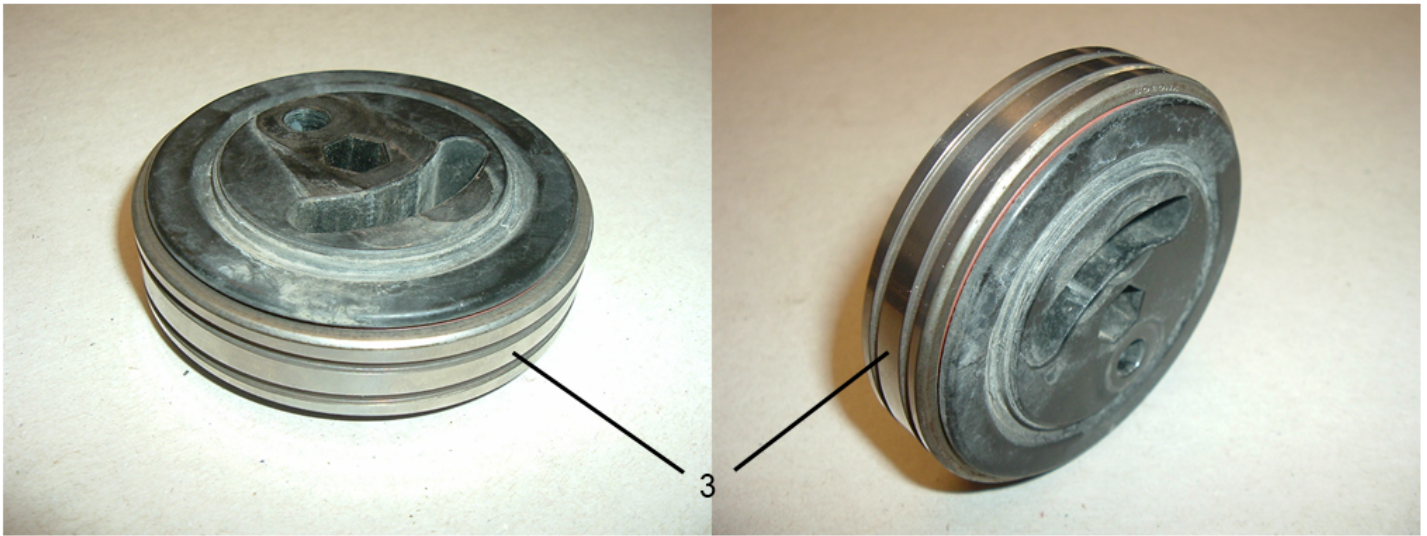
The outer ring on the pulley that is used to adjust the tension of the power steering pump drive belt may break. If this happens, you may hear an abnormal noise when turning the steering wheel. The power steering pump drive belt can come off, resulting in a sudden loss of power steering assist, which could result in a crash.

Failed: Black plastic outer race is missing (3)
Replace
