November 2018
FL796A-F
NHTSA #18V-699
Transport Canada #2018-551

Subject: Steering Wheel Fasteners

Models Affected: Specific Freightliner Cascadia vehicles, and Western Star 5700 vehicles, manufactured July 31, 2018, through August 2, 2018.

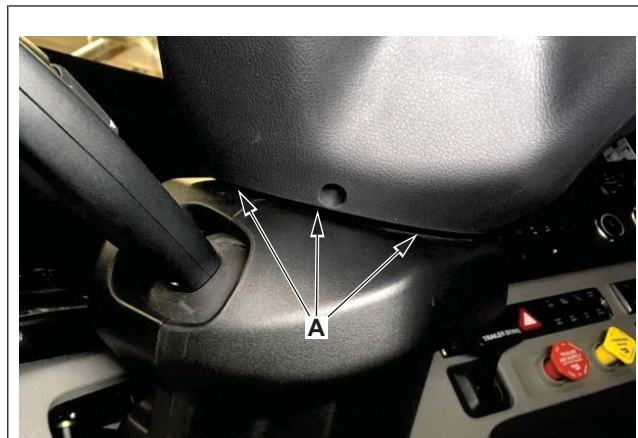
Fig. 1, Fully Seated Steering Wheel

A. On a fully seated steering wheel, the lower steering wheel overlaps the column cover.

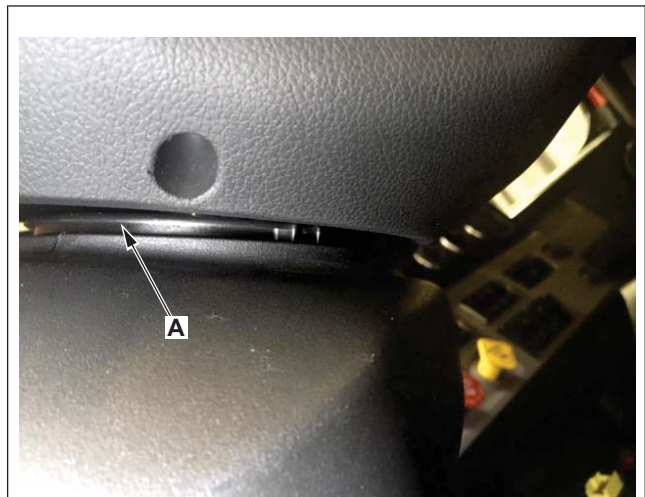
Fig. 2, Steering Wheel that is Not Fully Seated

A. When the steering wheel is not fully seated, there is a gap between the lower steering wheel and the column cover.

5. Verify that the fastener torque is $60 \text{ lbf}\cdot\text{ft} \pm 7$ ($80 \text{ N}\cdot\text{m} \pm 10$). If the torque is correct and there is no gap between the lower steering wheel and the column cover, no further action is necessary. Continue to step 33.
If the steering wheel is not fully seated (excessive gap), and/or if the steering wheel fastener cannot be properly torqued, continue to step 6.
6. Disconnect the batteries.
7. Unclip the clockspring harnesses from the steering wheel.
8. Remove the steering wheel screw, then remove the steering wheel.

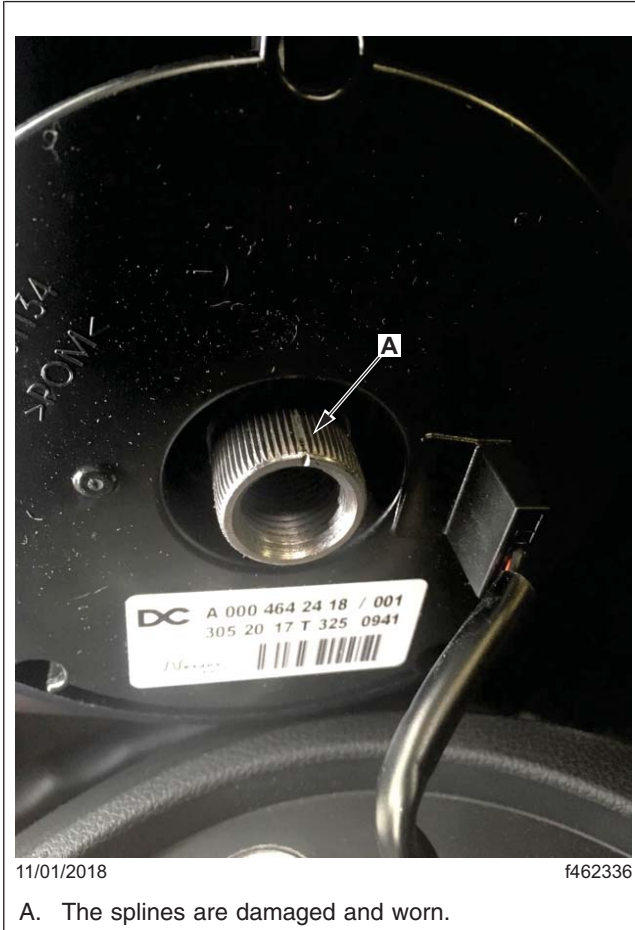
Fig. 4, Damaged Steering Column Splines

9. Inspect the steering column splines. There should be no wear or damage on the splines. See [Fig. 4](#) and [Fig. 5](#).
