Service Engineering Operations  
Customer Service Division

**TO:** All U.S. Ford and Lincoln Dealers  
**SUBJECT:** **NEW VEHICLE DEMONSTRATION / DELIVERY HOLD**  
**Safety Recall 18S29 - Supplement #1**  
Certain 2017-2018 Model Year Ford GT Vehicles  
Module Reprogramming  
**REF:** **Safety Recall 18S29**  
Dated November 19, 2018

In some of the affected vehicles, fluid pressure within the Active Aero wing valve block assembly can exceed the capabilities of the seals, which may result in a leak of hydraulic fluid. Leaking of hydraulic fluid in the presence of an ignition source can increase the risk of a fire.

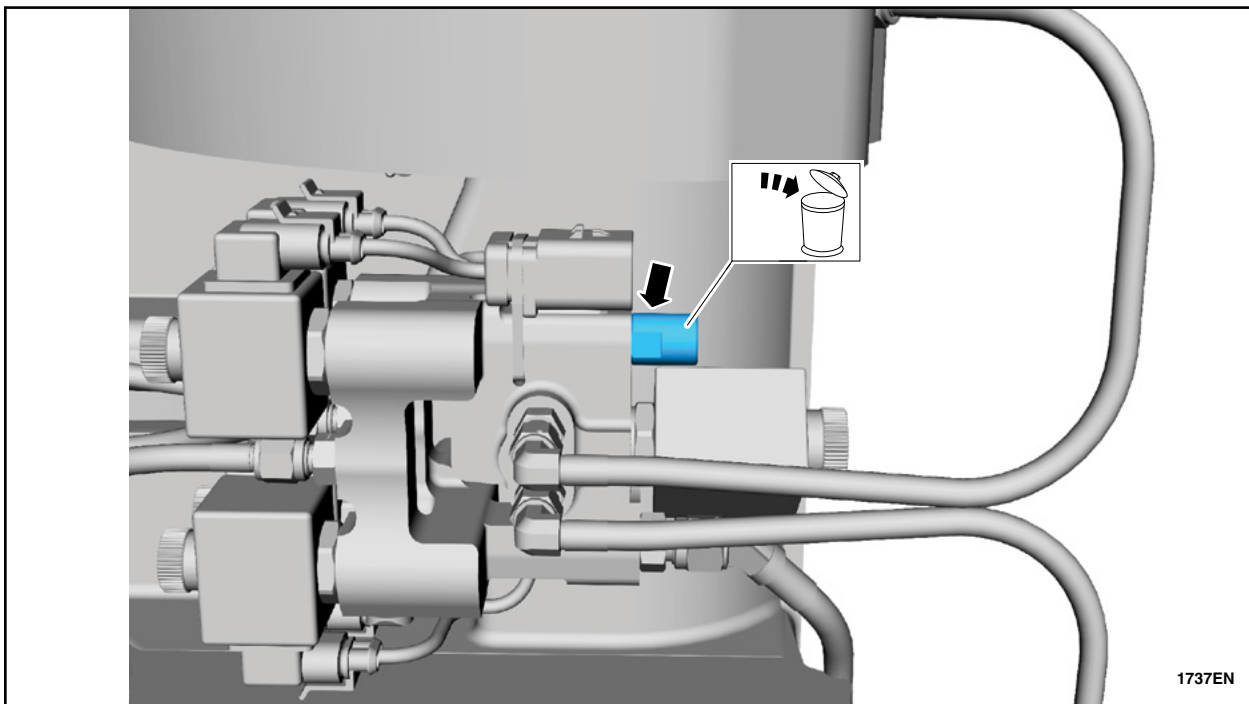
**FIGURE 9**

19. Remove and discard the Active Aero wing check valve. See Figure 9.
