David J. Johnson
Director
Service Engineering Operations
Ford Customer Service Division

February 22, 2019

SUBJECT: Safety Recall 18S34 – Supplement #1
Certain 2010 Milan and 2010-2012 Fusion and MKZ Vehicles
Passenger Airbag Module Replacement

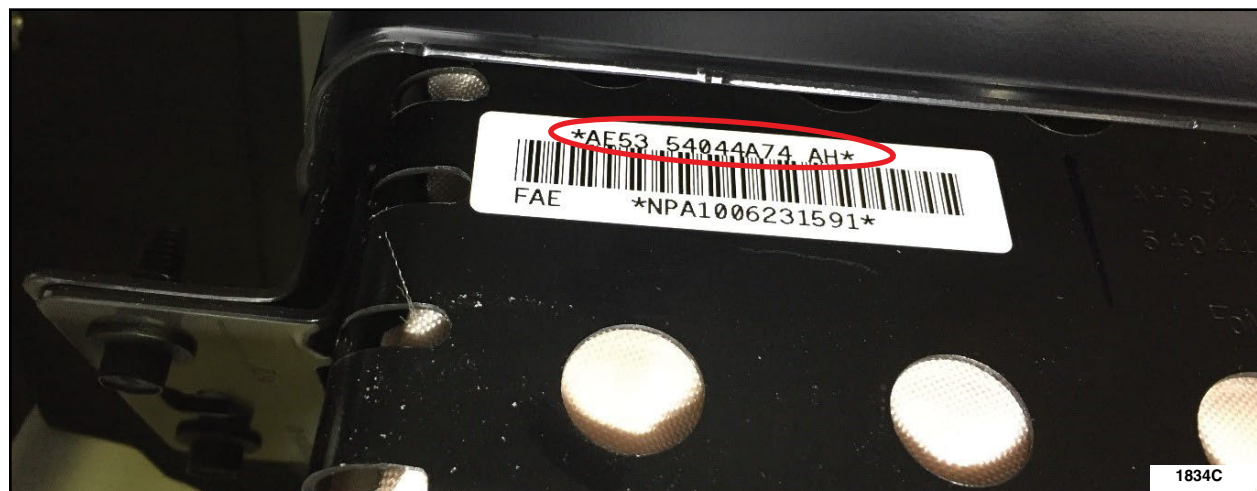
FIGURE 3

3. Inspect the passenger airbag module part number located on the white label. See Figure 3.

- For Fusion and Milan vehicles, if the passenger airbag module part number is AE5Z-54044A74-D, the inspection is complete. Close the glove compartment door.
- If the passenger airbag module is not AE5Z-54044A74-D, or the part number is not readable, proceed with the repair procedure.

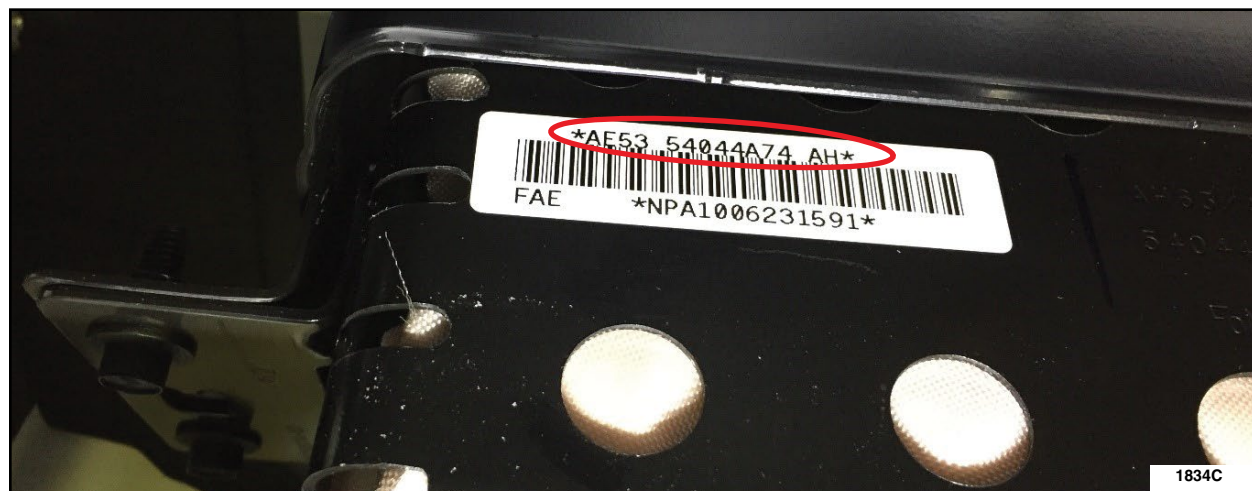
FIGURE 3

3. Inspect the passenger airbag module part number located on the white label. See Figure 3.

- For MKZ vehicles, if the passenger airbag module part number is AH6Z-54044A74-D, the inspection is complete. Close the glove compartment door.
- If the passenger airbag module is not AH6Z-54044A74-D, or the part number is not readable, proceed with the repair procedure.
