TO: Mercedes-Benz Dealer Principals, General Managers, Sales Managers, Service Managers, Parts Managers	FROM: Gregory Gunther, Department Manager, Vehicle Compliance and Analysis, Engineering Services
RE: Recall Campaign 2018 1200 10 Launch Notification Check Steering Coupling Locking Status MY 18- C-Class Coupe, E-Class Coupe (205, 238)	DATE: December 21, 2018

Campaign No. 2018120010, December 2018

SUBJECT: **Models C-Class and E-Class Coupe vehicles (205 and 238 platforms)
Model Year 2018
Check steering coupling lock; rework, if necessary**

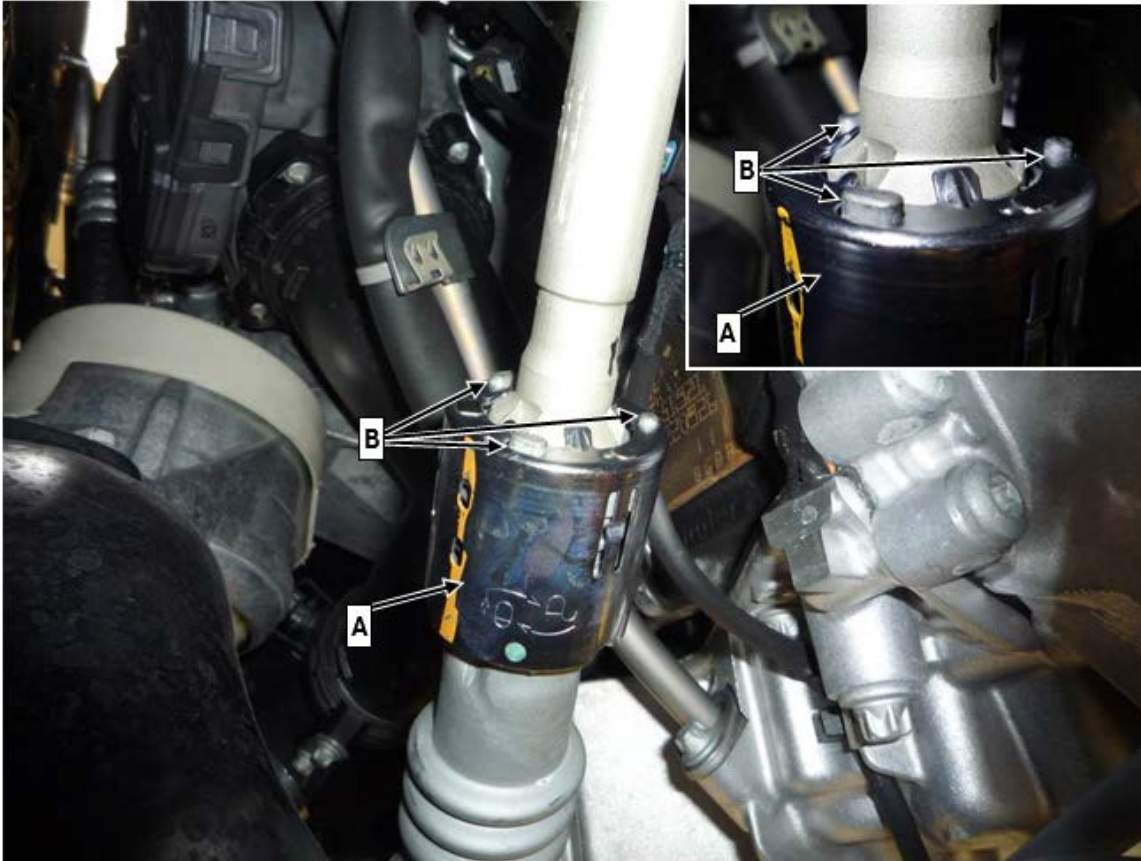
Figure 1

1. Remove center and rear section of lower engine compartment paneling.
2. Check lock (A) of the steering coupling by touch and by performing a visual inspection (Figure 1).

- i** Lock (A) is locked correctly, if **all** of the following conditions are met:
- The **three** journals (B) must protrude by **at least 0.5 mm** all around
 - Lock (A) should **not** be able to be twisted without stroke movement

- a. If steering coupling is **correctly** locked: **End measure.**
- b. If steering coupling is **not correctly** locked: Carry out **work procedure.**

1. Lock steering coupling correctly.
 - i** For basic data, see **AR46.10-P-8000-01LW**
