TO: Mercedes-Benz Dealer Principals, General Managers, Sales Managers,	FROM: Gregory Gunther, Department Manager, Vehicle Compliance and
Service Managers, Parts Managers	Analysis, Engineering Services
RE: Recall Campaign Launch Notification	
2019040025 Check Steering Boot	DATE: April 19, 2019
MY18-19 S-Class, S-Class Coupe (222, 217)

Campaign No. 2019040025, April 2019

SUBJECT: Model S-Class and S-Class Coupe vehicles (222 and 217 platforms) Model Years 2018-2019 **Check and Rework Steering Boot**

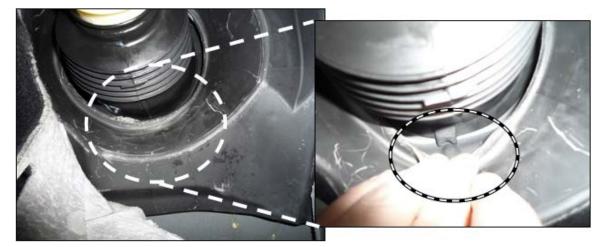
Figure 3

5. Press damping in lower area of steering boot downward until the mark is visible (figure 3).

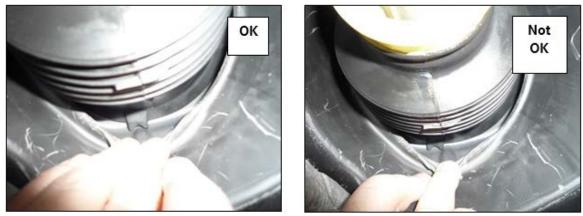
Figure 4

6. Check installation position of steering boot.

i Check position of markings on steering boot and firewall (figure 3)

- a. Installation position of steering boot NOT OK: Carry out Work Procedures 1 and 2.
- b. Installation position of steering boot OK: Carry out Work Procedure 2.
