TO: Mercedes-Benz Dealer Principals, General Managers, Sales Managers, Service Managers, Parts Managers	FROM: Gregory Gunther, Department Manager, Vehicle Compliance and Analysis, Engineering Services
RE: Recall Campaign Launch Notification Check Headlight Adjustment Screw, Rework if Necessary MY19 257 (CLS-Class)	DATE: March 8, 2019

Campaign No. 2019020007, March 2019

SUBJECT: **Model CLS-Class vehicles (257 platform)
Model Year 2019****Rework left and right covers of screw for horizontal headlamp adjustment**

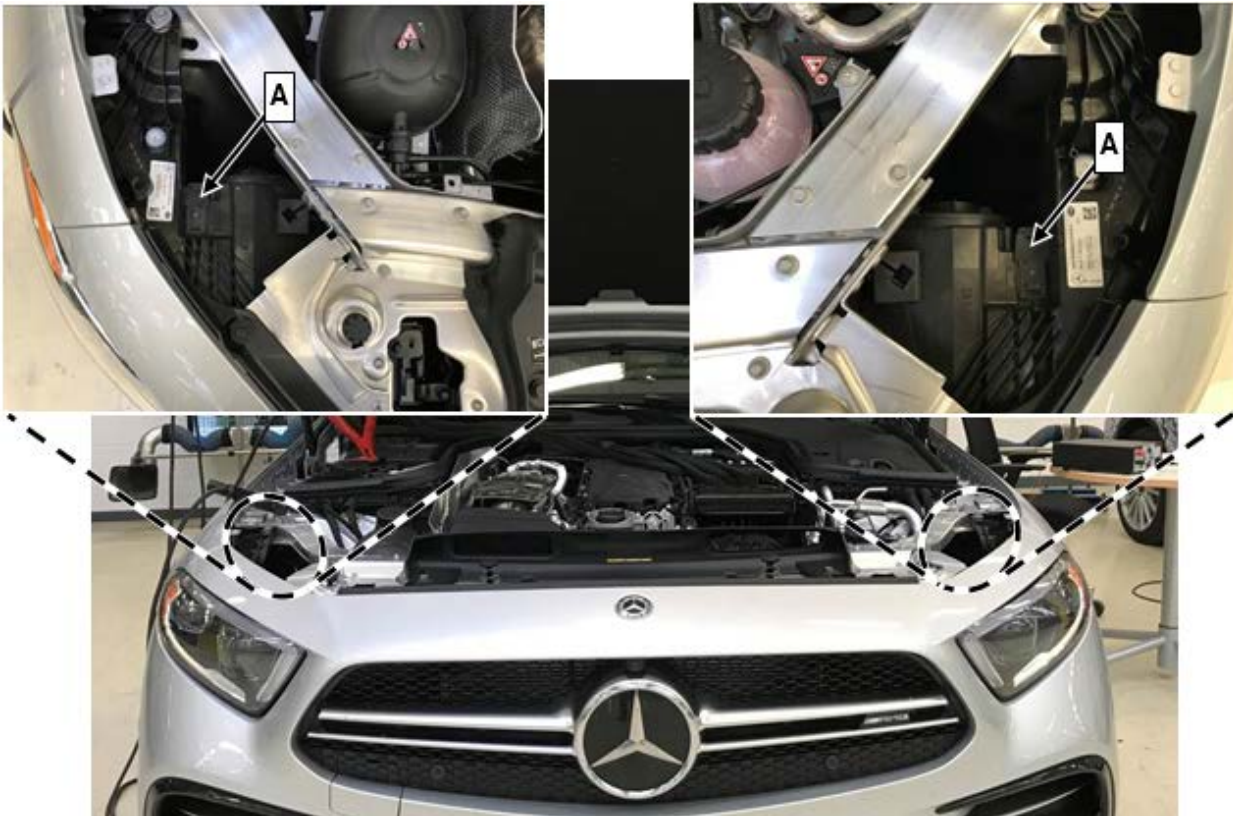
Figure 1

Daimler AG (“DAG”), the manufacturer of Mercedes-Benz vehicles, has determined that on certain MY 2019 CLS-Class vehicles (257 platform), the horizontal adjustment mechanism might be accessible which does not meet the requirements of FMVSS 108. Subject vehicles are designed to meet this requirement by sealing off the headlamp horizontal adjustment screw with a non-removable sealing cap after initial adjustment in the manufacturing plant. An authorized Mercedes-Benz dealer will check the horizontal headlight adjusting screws on the affected vehicles and seal them, if necessary

1. Open hood.
2. Open left and right cover locks (A) (Figure 1).
