TO: Mercedes-Benz Dealer Principals, General Managers, Sales Managers, Service Managers, Parts Managers	FROM: Gregory Gunther, Department Manager, Vehicle Compliance and Analysis, Engineering Services
RE: Recall Campaign Launch Notification Check Pano Roof Bonding, Rework if Necessary MY18-19 X156 (GLA-Class)	DATE: April 5, 2019

Campaign No. 2019030006, March 2019

SUBJECT: **Model GLA-Class vehicles (156 platform)**
Model Year 2018-2019
Check panoramic roof for leak tightness and rework, if necessary

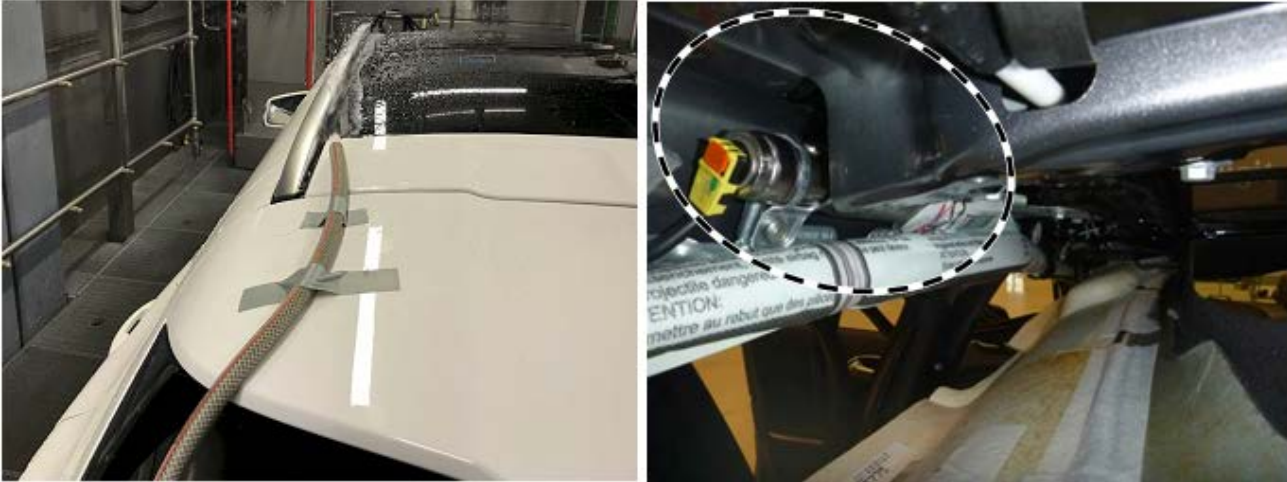
Figure 1

2. Perform leak test (**rain test**) (**figure 1**).

i Apply water (**at least 10 l/min**) to panoramic glass roof all-round.
