## **IMPORTANT SAFETY RECALL 18V-008 (SN663)**

SN-663

Models Affected: XTPro56 & XTPro 60 Aerials

SUBJECT: Single Stick Control Adjustment

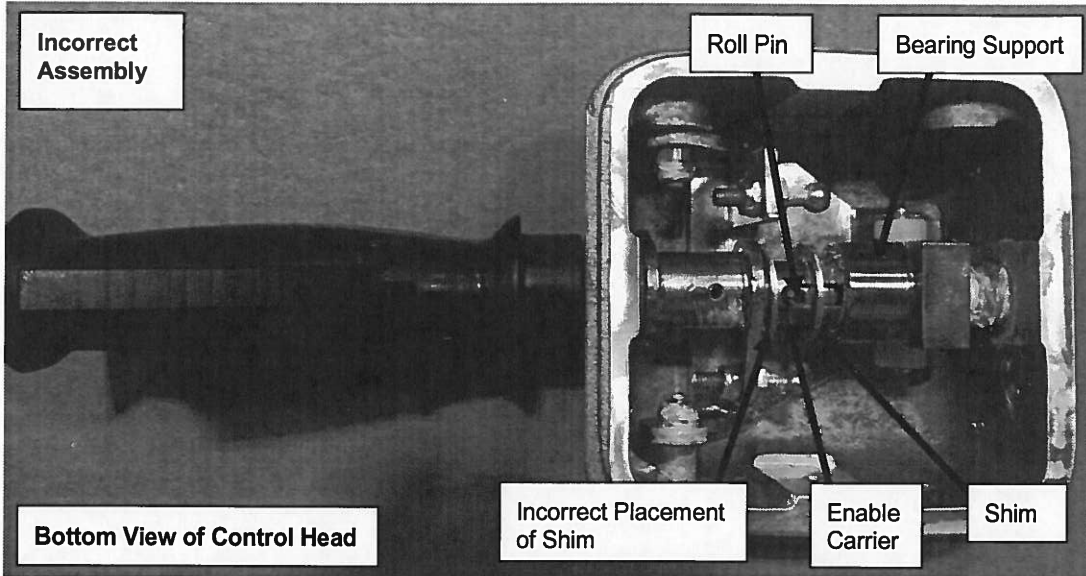
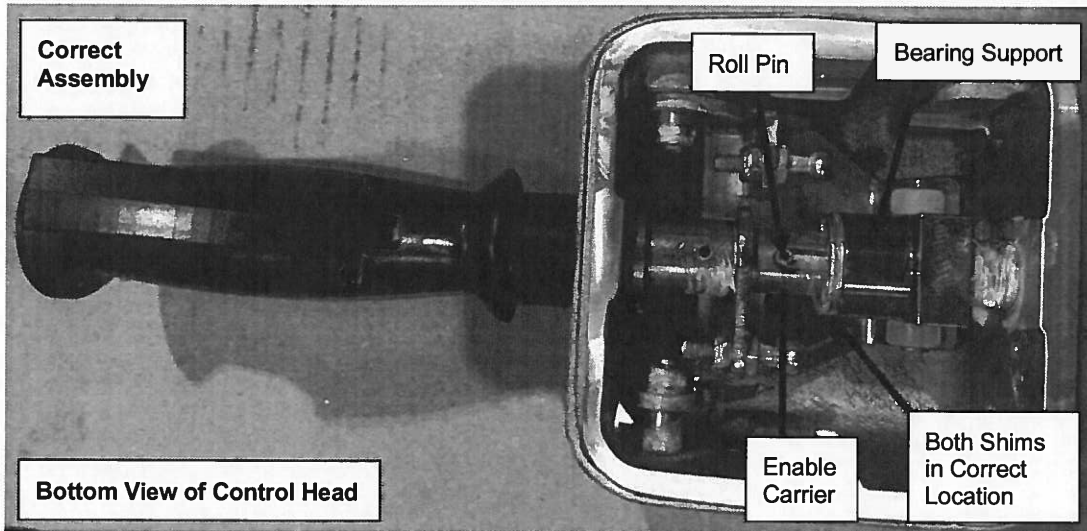
- a. Remove the plastic cap and lower the boot over the single stick mechanism.
  - b. Inspect the position of the two shims on the enable carrier.
  - c. If only one shim is between the roll pin and bearing support, the single stick is assembled incorrectly. Contact your local TEREX dealer to arrange repair. The control head must be assembled properly to provide allowance for wear to attain rated boom speeds.

- d. If both shims are between the roll pin and bearing support, the single stick is assembled properly. No further action is required for this bulletin. Continue to perform regular inspections and maintenance as stated in the manuals.
