#### IMPORTANT SAFETY RECALL This notice applies to your vehicle. See attached serial number list.

NHTSA Safety Recall No. 1**8**V-693

# **Customer Service Notice**

### Hose Sock and Drain Hole Modification

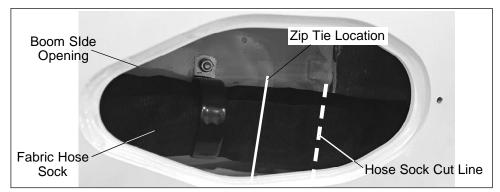
Figure 3 — Securing the Hose Sock

- 3.Look inside the opening of the articulating arm for the hose bundle and the hose sock covering. Look toward the band of arrows on the side of the boom. The hose sock should not extend past the band of arrows location into the steel boom section..
- 4. If fabric hose sock extends past the arrow band, it must be removed. Continue to Step 5. If the hose sock does not go past the arrows line, continue to Step 7.
- 5. Use a zip tie to secure the fabric hose sock in place about 1" to 2" from the black hose clamp bolted inside the boom (refer to Figure 3). Carefully cut and remove the hose sock about 1" to 2" past the zip tie (refer to Figure 3).
