Subject: Heavy Duty Clutch May Not Achieve Full Departure – Mechanical and Automated

Document Number: CLIB-0035

Date: December 12, 2018

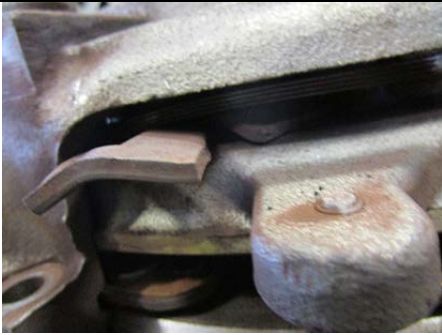
Customers may experience various fault codes and/or clutch release complaints due to broken clutch levers in self-adjust clutches used with automated and manual transmissions. Figures 1-3 below illustrate a failed clutch lever.

Figure 1: Broken Lever Pieces	Figure 2: Broken Lever found in Clutch Housing	Figure 3: Broken Lever found in Cover Assembly

Service Option	Description
1.	<p>If a vehicle is at a repair facility for any transmission or clutch related issue that requires transmission removal, request and record the installed clutch part number and serial number.</p> <ul style="list-style-type: none"> • If the clutch serial number is between the Start and End indicated below, the repair facility is to replace the clutch: <ul style="list-style-type: none"> ○ Start: AU1704010001 / SL1704010001 – 17(Year) 04(Month) 01(Day) ○ End: AU1806019999 / SL1806059999 – 18(Year) 06(Month) 01 or 05(Day). • Replace clutch using the standard warranty process.
