Subject: Heavy Duty Clutch May Not Achieve Full Departure – Mechanical and Automated

Document Number: CLIB-0035

Date: December 12, 2018

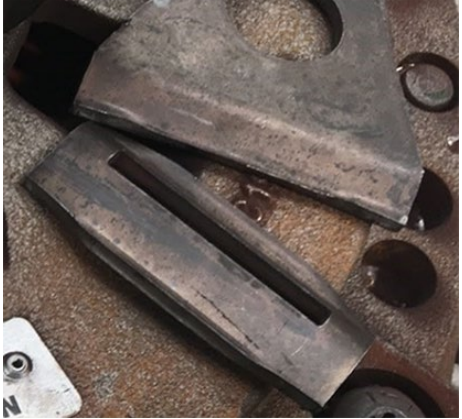
Customers may experience various fault codes and/or clutch release complaints due to broken clutch levers in self-adjust clutches used with automated and manual transmissions. Figures 1-3 below illustrate a failed clutch lever.

Figure 1: Broken Lever Pieces	Figure 2: Broken Lever found in Clutch Housing	Figure 3: Broken Lever found in Cover Assembly

Service Option	Description
1.	<p>If a vehicle is at a repair facility for any transmission or clutch related issue that requires transmission removal, request and record the installed clutch part number and serial number.</p> <ul style="list-style-type: none"> • If the clutch serial number is between the Start and End indicated below, the repair facility is to replace the clutch: <ul style="list-style-type: none"> ○ Start: AU1704010001 / SL1704010001 – 17(Year) 04(Month) 01(Day) ○ End: AU1806019999 / SL1806059999 – 18(Year) 06(Month) 01 or 05(Day). • Replace clutch using the standard warranty process.

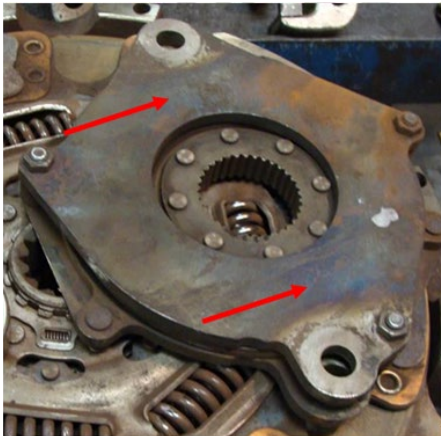
- ECA Clutch Kit Part Number – 122002-35EX (1850 ft-lbs) or 122003-42 (2250 ft-lbs) minus LCIB should be utilized. Inspect LCIB for excessive heat, if heat is present use 122002-35A or 122003-42A, see Figure 4.

Note: If 122002-35EX is not available use 122002-35A.

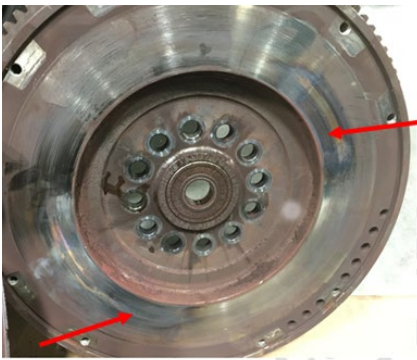
Figure 5.

- Parts outside of the above listed are not covered under this document. Example: oil pan gaskets, engine mounts, release bearing/cross shaft grease tubes, crank sensor, or u-joints.
- One 1 u-joint strap kit will be covered.
- Pilot Bearings will be covered. Replace with OEM recommended pilot bearing or Reference CLTS1271 for recommended pilot bearings. Maximum reimbursement is \$35 USD.
- Gaskets related to exhaust and PTO removal/installation will be covered.
- If hot spots are identified (Figure 5), Flywheel resurfacing will be covered up to a maximum \$130 USD charge.
