Subject: Heavy Duty Clutch May Not Achieve Full Departure – Mechanical and Automated

Document Number: CLIB-0035

Date: December 12, 2018

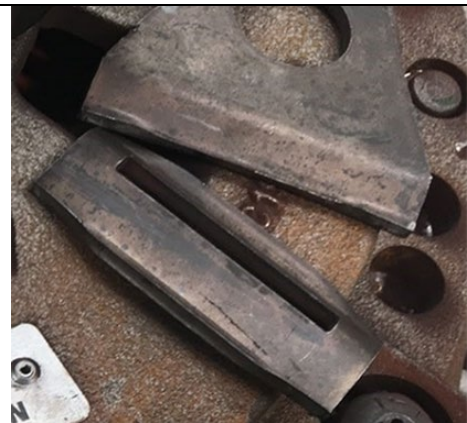
Customers may experience various fault codes and/or clutch release complaints due to broken clutch levers in self-adjust clutches used with automated and manual transmissions. Figures 1-3 below illustrate a failed clutch lever.

Figure 1: Broken Lever Pieces	Figure 2: Broken Lever found in Clutch Housing	Figure 3: Broken Lever found in Cover Assembly

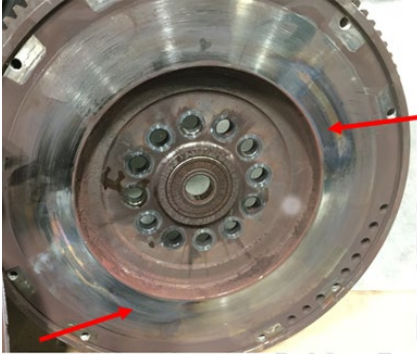
Figure 5.

- Gaskets related to exhaust and PTO removal/installation will be covered.
- If hot spots are identified (Figure 5), Flywheel resurfacing will be covered up to a maximum \$130 USD charge.
