BACKED BY
Roadranger
SUPPORT

Subject: Heavy Duty Clutch May Not Achieve Full Departure – Mechanical and Automated

Document Number: CLIB-0035

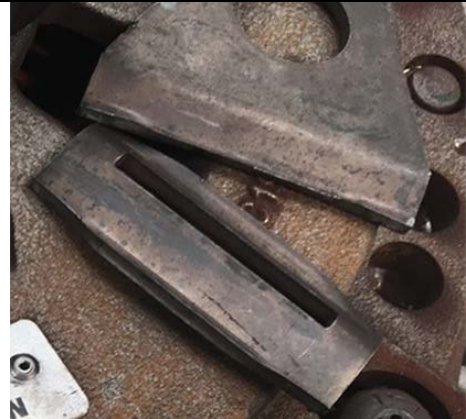
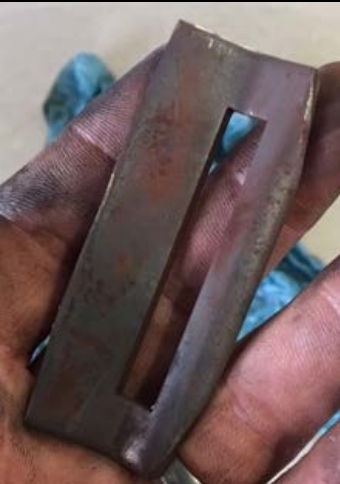
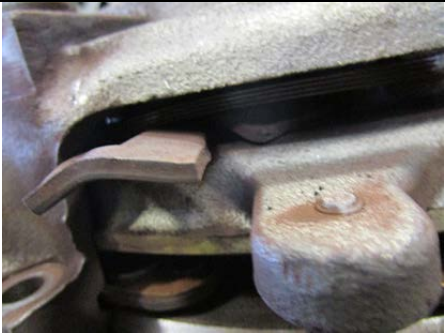
Customers may experience various fault codes and/or clutch release complaints due to broken clutch levers in self-adjust clutches used with automated and manual transmissions. Figures 1-3 below illustrate a failed clutch lever.

Figure 1: Broken Lever Pieces	Figure 2: Broken Lever found in Clutch Housing	Figure 3: Broken Lever found in Cover Assembly

There are three clutch service strategy options:

Service Option	Description
1.	<p>If a vehicle is at a repair facility for any transmission or clutch related issue that requires transmission removal, request and record the installed clutch part number and serial number.</p> <ul style="list-style-type: none"> • If the clutch serial number is between the Start and End indicated below, the repair facility is to replace the clutch: <ul style="list-style-type: none"> ○ Start: AU1704010001 / SL1704010001 – 17(Year) 04(Month) 01(Day) ○ End: AU1806019999 / SL1806059999 – 18(Year) 06(Month) 01 or 05(Day). • Replace clutch using the standard warranty process.

2.	<p>Automated Transmission Complaints:</p> <ol style="list-style-type: none"> 1. Request and record the installed clutch part number and serial number. Download Service Activity Report (SAR) to Eaton ServiceRanger diagnostic tool and “Send to Eaton”. <p>Note: ServiceRanger must be connected to internet to successfully complete upload of the SAR.</p> <ol style="list-style-type: none"> 2. If any combinations of fault codes 64/7, 27/7, 71/7, 71/11, 73/7, or 45/7 have set and the vehicle is exhibiting a “getting into gear from neutral” or “unable to achieve neutral when selected” complaint replace clutch using the standard warranty process if serial number is between the above Start and End descriptions. 3. If the above stated fault codes have not set and the vehicle is exhibiting the above symptoms or if the vehicle has secondary damage due to a clutch failure lever failure, please call 800-826-4359 for assistance.

3.	<p>Mechanical Complaints:</p> <ul style="list-style-type: none"> • Request and record the installed clutch part number and serial number. • Reference Mechanical Transmission Complaints in the Issue Description section, if complaint is confirmed refer to clutch serial numbers below. <ul style="list-style-type: none"> ○ If the clutch serial number is between the Start and End range, replace the clutch. Replace with no charge clutch if possible, if a no charge clutch will not be accepted, advise repair facility to replace clutch using the standard warranty process.
-----------	---
