PRODUCT CAMPAIGN BULLETIN

<p>APPLICABILITY: 2009-2013 model year Legacy 2009-2013 model year Outback 2009-2013 model year Forester 2009-2013 model year Tribeca 2009-2011 model year Impreza 2009-2013 model year WRX and STI</p> <p>SUBJECT: Takata Front Passenger Airbag Inflator Replacement (2018 Calendar year expansion)</p>	<p>NUMBERS: TKA-18R TKB-18R TKC-18R</p> <p>DATE: 02/09/18 REVISED: 12/28/23</p> <p>NHTSA ID: 18V-012 18V-013 18V-014</p>
---	---

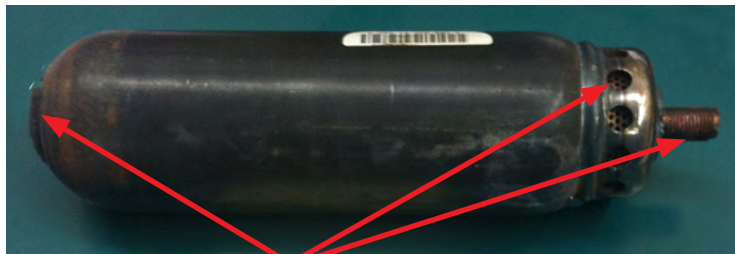
The shape, holes, and copper-colored stud indicate this not a Genuine Subaru inflator.

- **Do not proceed with this repair if your inspection reveals a non-Genuine Subaru airbag module has been installed in the vehicle.** Follow the instructions described in the “Counterfeit Airbag Information” Dealer Advisory Bulletin.
