PRODUCT CAMPAIGN BULLETIN

<p>APPLICABILITY: 2009-2013 model year Legacy 2009-2013 model year Outback 2009-2013 model year Forester 2009-2013 model year Tribeca 2009-2011 model year Impreza 2009-2013 model year WRX and STI</p> <p>SUBJECT: Takata Front Passenger Airbag Inflator Replacement (2018 Calendar year expansion)</p>	<p>NUMBERS: TKA-18R TKB-18R TKC-18R</p> <p>DATE: 02/09/18 REVISED: 12/21/22</p> <p>NHTSA ID: 18V-012 18V-013 18V-014</p>
---	---

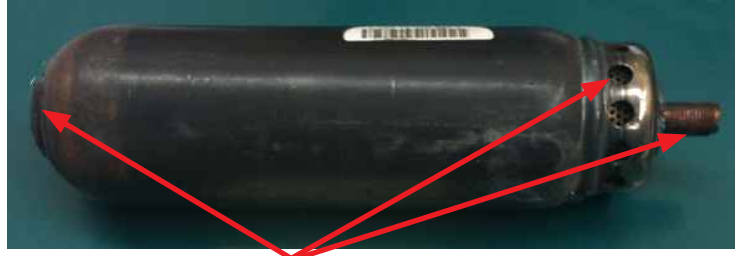
The shape, holes, and copper-colored stud indicate this not a Genuine Subaru inflator.

- **Do not proceed with this repair if your inspection reveals a non-Genuine Subaru airbag module has been installed in the vehicle.** Follow the instructions described in the “Counterfeit Airbag Information” Dealer Advisory Bulletin.

- Document the presence of the aftermarket or counterfeit device on the repair order and with photos. Report this information immediately on a Quality Monitoring Report (QMR). **IMPORTANT:** When entering a related QMR, use failure code **ULF** and **NOT** the campaign fail code.
