TECHNICAL INSTRUCTIONS

SAFETY RECALL GOP

FRONT PASSENGER AIRBAG INFLATOR MODULE

CERTAIN 2010-2013 MY 4Runner

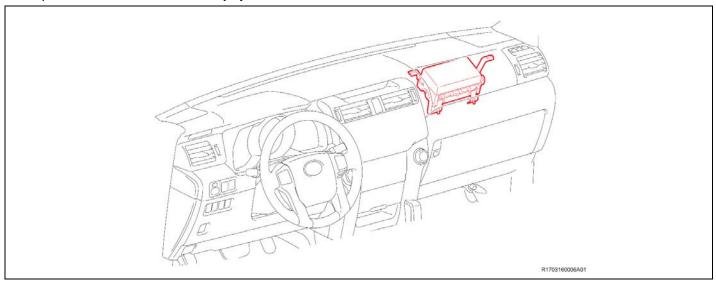
The subject vehicles are equipped with front passenger airbag inflators produced by Takata. According to Takata, the propellant in these inflators may degrade after prolonged exposure to high absolute humidity and fluctuating high temperatures. Degraded propellant can cause inflator rupture during airbag deployment. In the event of an inflator rupture, metal fragments could pass through the airbag cushion material, striking the vehicle occupants, and result in serious injury or death.
