SAFETY RECALL GOR

FRONT PASSENGER AIRBAG INFLATOR MODULE

CERTAIN 2010 MY 4RUNNER

UPDATE 11-20-2018

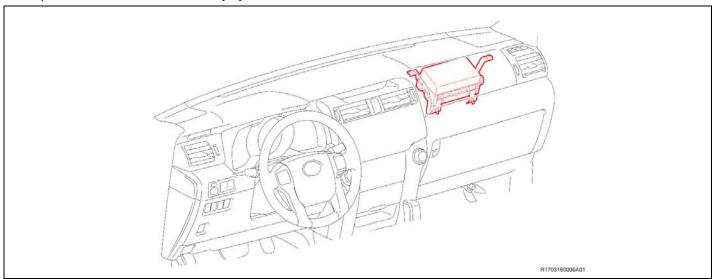
The subject vehicles are equipped with front passenger airbag inflators produced by Takata. According to Takata, the propellant in these inflators may degrade after prolonged exposure to high absolute humidity and fluctuating high temperatures. Degraded propellant can cause inflator rupture during airbag deployment. In the event of an inflator rupture, metal fragments could pass through the airbag cushion material, striking the vehicle occupants, and result in serious injury or death.
