2006 B-SERIES - PASSENGER AIR BAG SAFETY RECALL 2318A

March 6, 2026. Added video installation requirement and additional links

PASSENGER AIR BAG SAFETY RECALL 2318A
REPAIR PROCEDURE

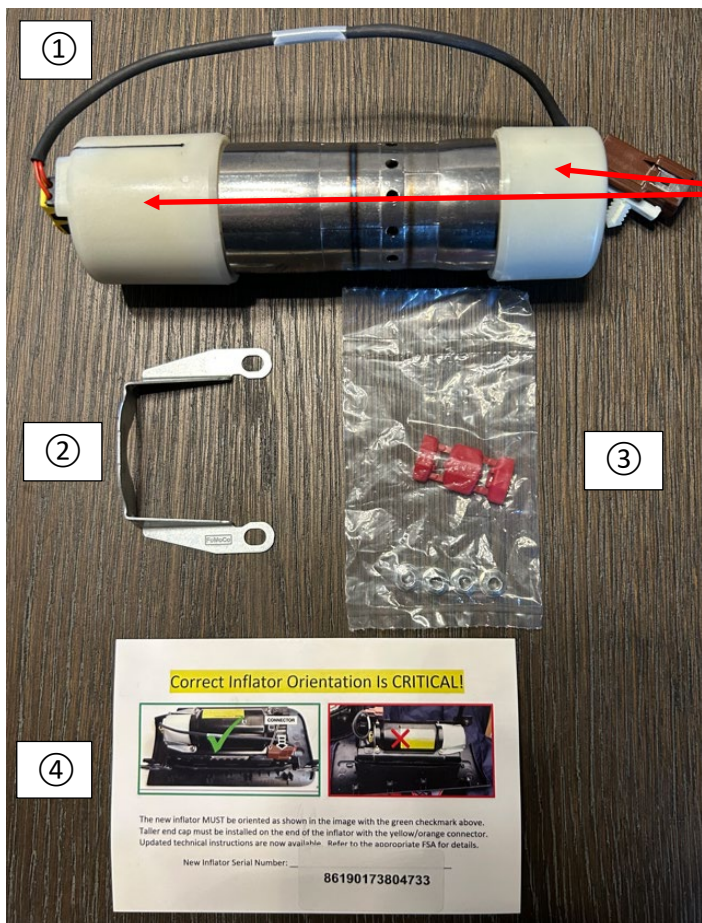
1. Inflator – **DO NOT REMOVE END CAPS AND INSTALL PREASSEMBLED, WITH THE SHORTER CAP FIRST (TAIL END CAP) INTO THE MODULE**
2. Bracket
3. Nuts (4) and clip (1)
4. PLEASE READ THIS WARNING LABEL

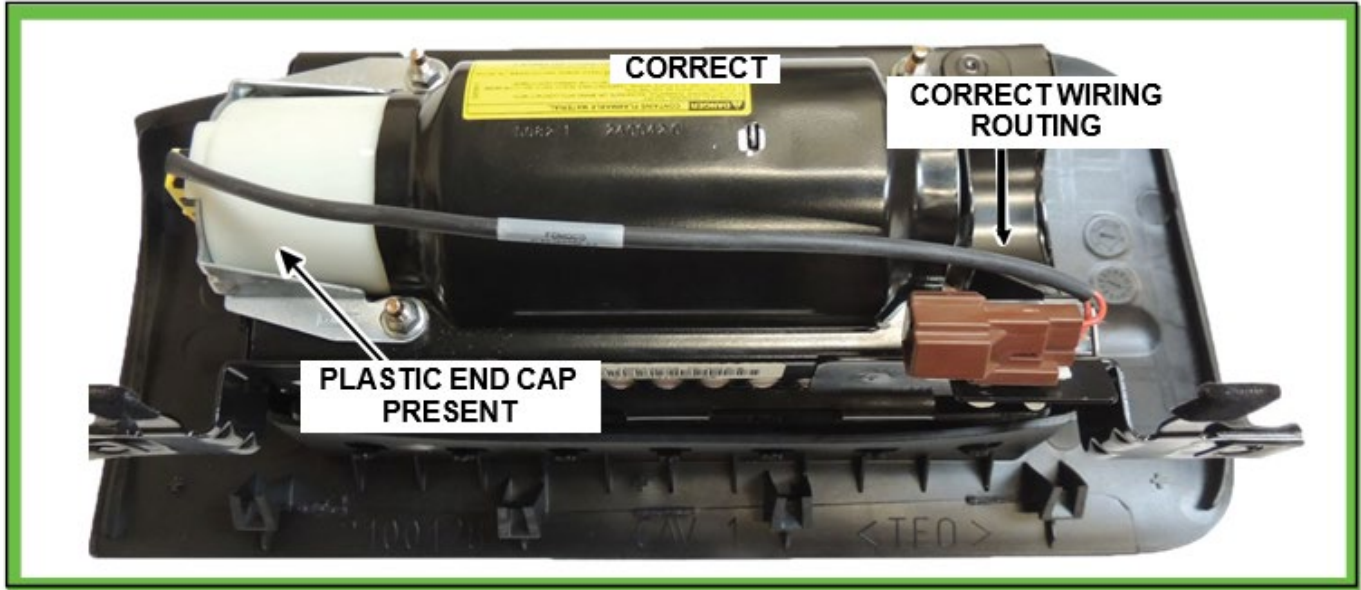
FIGURE 1 – GOOD - CORRECT INSTALLATION

- 13. Confirm the plastic end caps are installed on correct ends of the inflator and the inflator is installed in the correct orientation (GOOD CONDITION - FIGURE 1). FIGURE 2 – Shows a NO GOOD (NG) CONDITION WITH AN INCORRECT INFLATOR INSTALLATION.

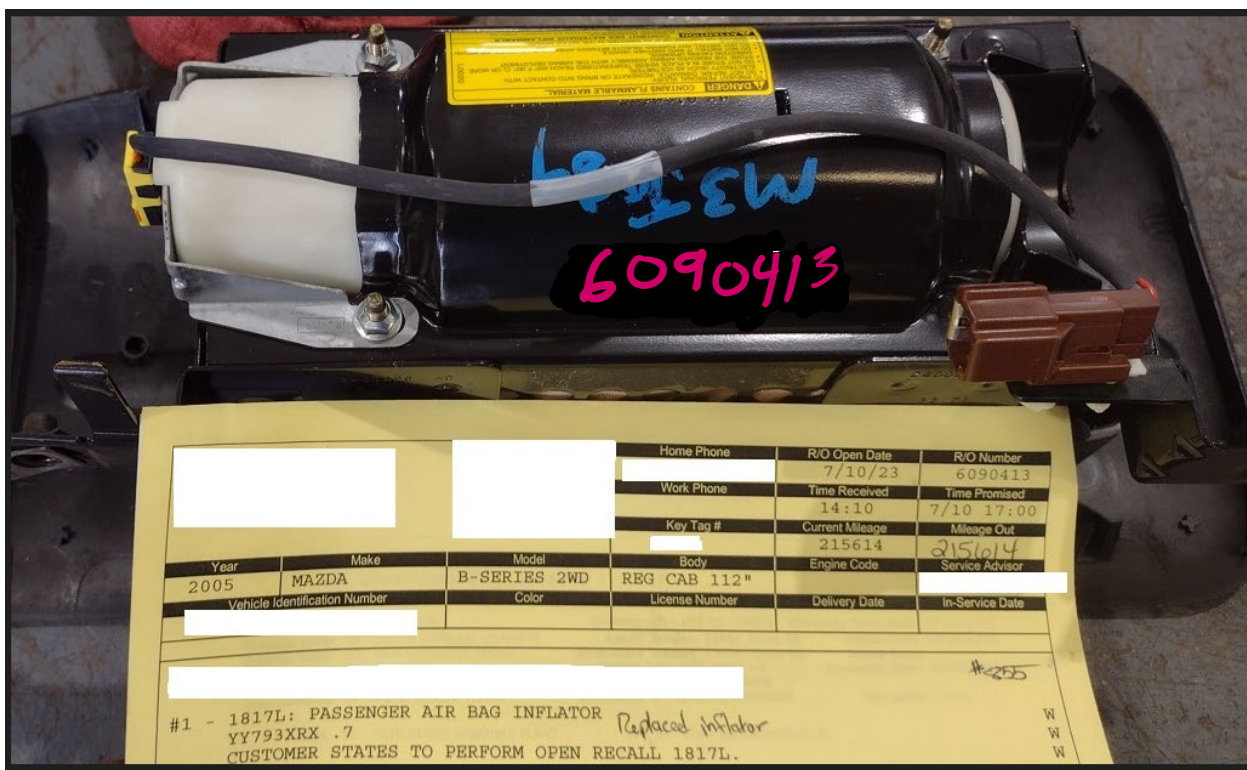
- a. The large left cap has a notch in the up position ABOVE the bracket. You should NOT see the silver inflator on the left side.
- b. The wire is across the inflator, with the yellow connector on the left.
- c. Your dealer RO# is written on the inflator module housing
- d. The repair order is clearly visible in the photo. For dealers on Electronic Repair Order, the claim must have a clear pdf or jpg repair order attached as a D01 attachment ID matching the repair order on the inflator.

14. FINAL CHECK AND PHOTO REQUIREMENT: If any step is not correct **DO NOT PROCEED**. **Required Photo example showing correct wiring:** Write the RO# on the case of the inflator that you are repairing with a grease pencil. Alternatively you can use the RO as shown below in the photo.
