TECHNICAL SERVICE BULLETIN

Indian Motorcycle

Bulletin Number: I-18-01
Model Years: 2015-17

SUBJECT: 2015-2017 Roadmaster Trunk Jumper Harness

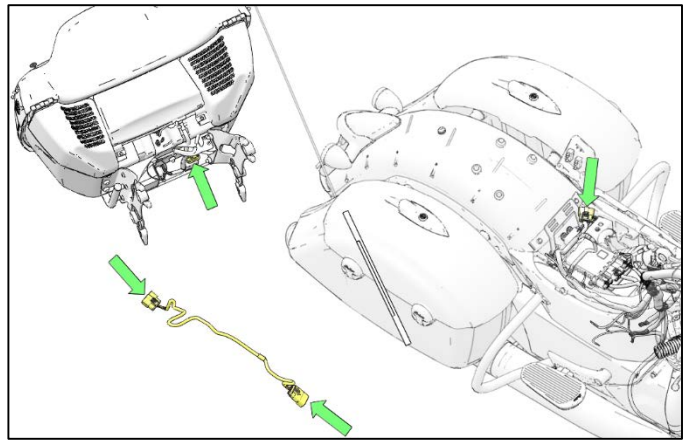
19. Inspect for corrosion in both ends of the trunk jumper harness and interfacing connectors as shown by the arrows (4 connectors).

Pay special attention to the white terminal lock plate during inspection. If corrosion is present, the blue/green residue will be most evident there, as pictured below in the corrosion present images.

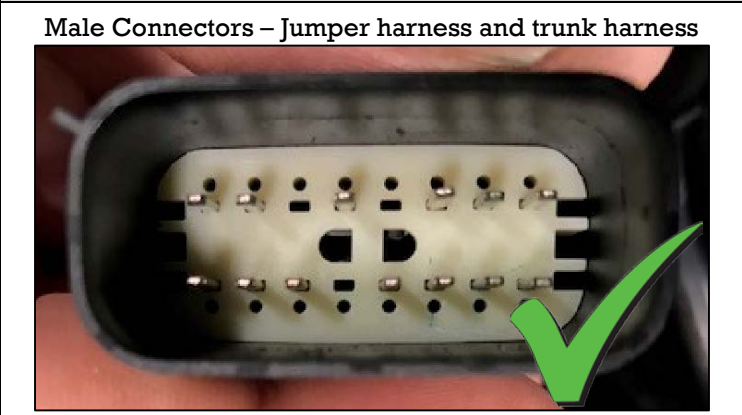
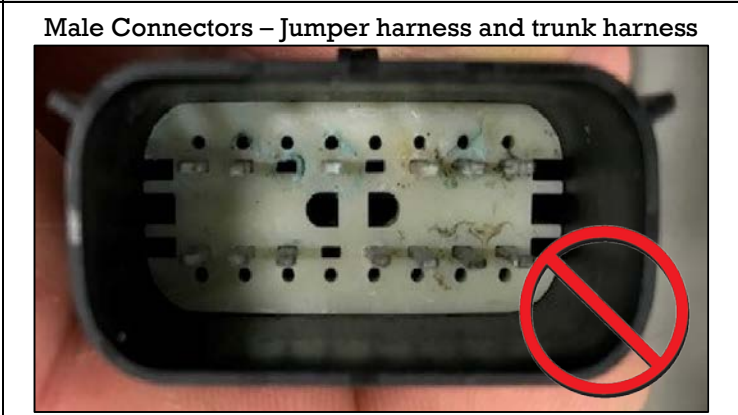
No corrosion present.

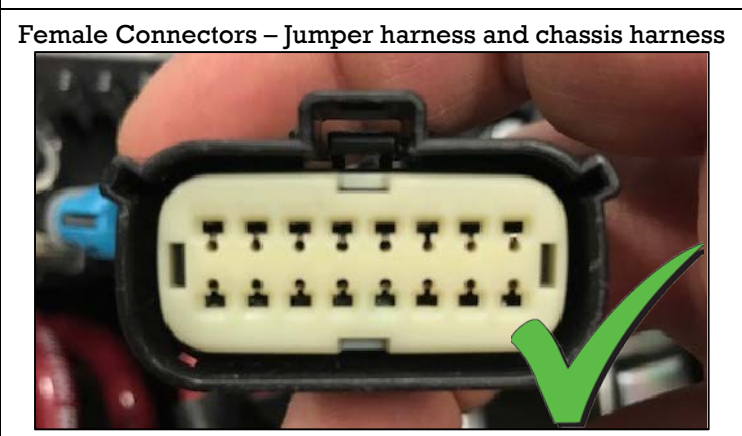
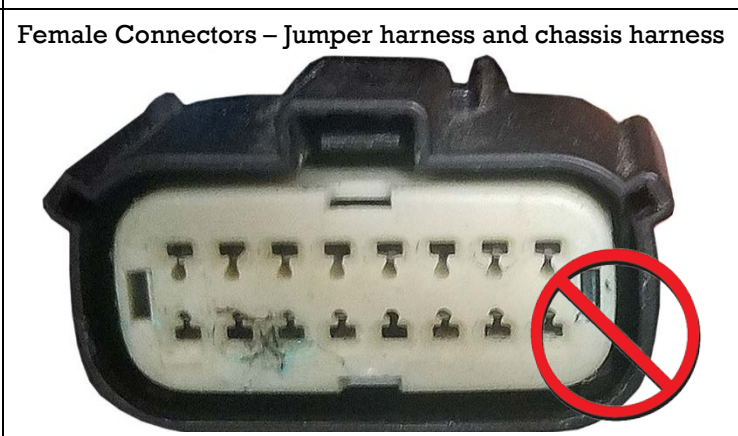
Corrosion present, proceed to I-18-01-B.
US/CAN: Submit an Ask Polaris Service & Warranty Question > Vehicle Diagnostic Question case.
INT'L: Contact your Country Service Department

If corrosion **IS** present, take pictures of the corrosion and proceed to [I-18-01-B](#). If corrosion is **NOT** present, proceed to step 19 to install the new jumper harness and complete the repair.
