SAFETY RECALL BULLETIN

SUBJECT: DRIVE BELT AUTO TENSIONER – SAFETY RECALL CAMPAIGN			No: SR-18-001
			DATE: March 2018
			MODEL: See Below
CIRCULATE TO:	<input checked="" type="checkbox"/> GENERAL MANAGER	<input checked="" type="checkbox"/> PARTS MANAGER	<input checked="" type="checkbox"/> TECHNICIAN
<input checked="" type="checkbox"/> SERVICE ADVISOR	<input checked="" type="checkbox"/> SERVICE MANAGER	<input checked="" type="checkbox"/> WARRANTY PROCESSOR	<input checked="" type="checkbox"/> SALES MANAGER

This campaign bulletin instructs dealers to inspect and, if necessary, replace the drive belt auto tensioner with a countermeasure part.

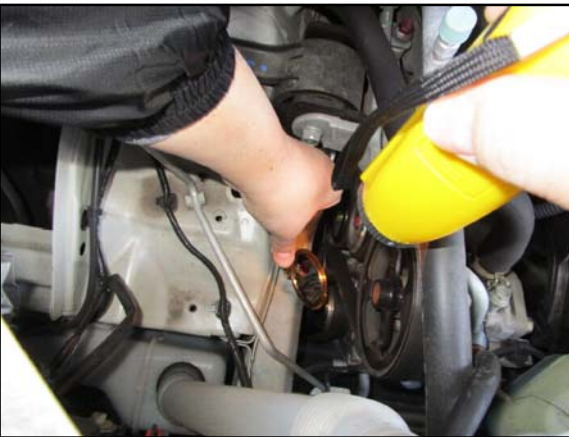
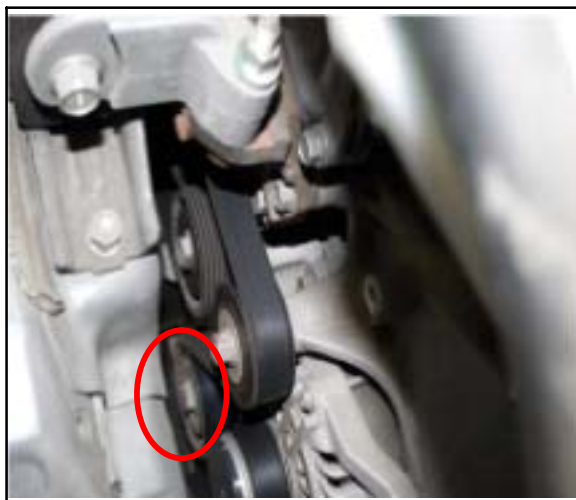
2. Inspect the auto tensioner flange with a mirror and a flashlight to check whether the flange is before (concave type flange) or after (straight type flange) the countermeasure.

- a. Placing the mirror closer to the auto tensioner along the drive belt.

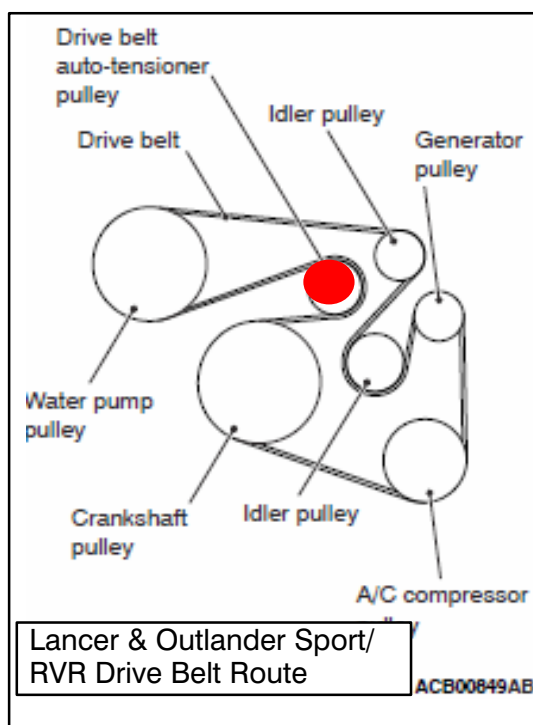
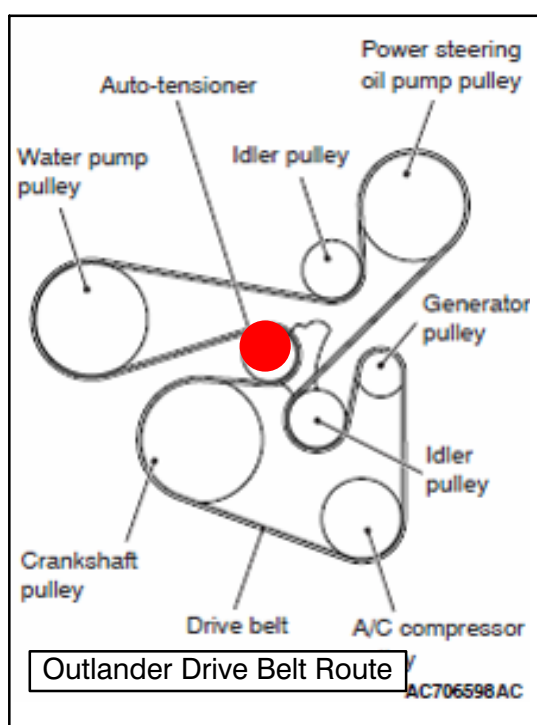
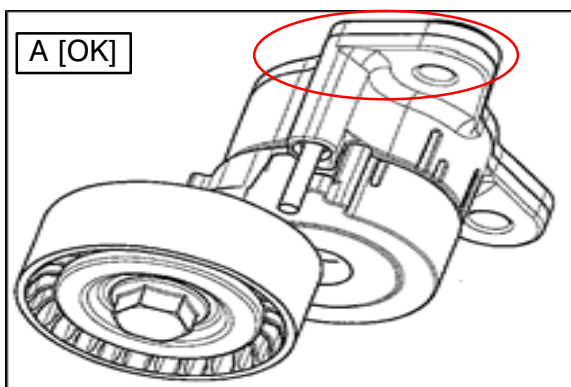
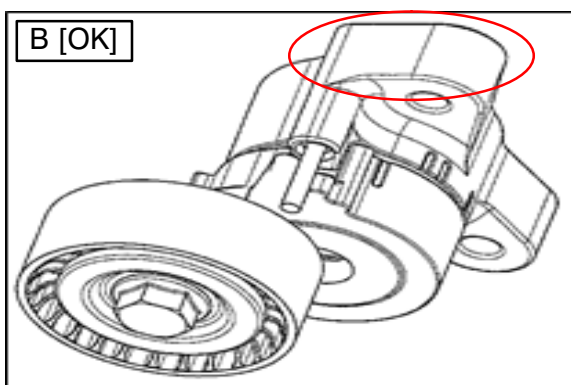
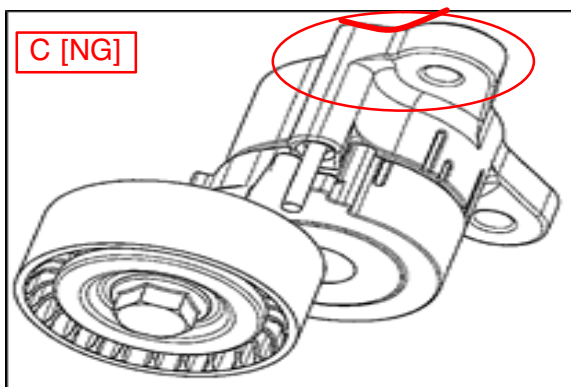
3. Check the auto tensioner and note the flange shape.
 - a. If the flange is straight, as illustrated in figures A and B, **leave as is** and go to **step 4**.
 - b. If the flange is concave, as illustrated in figure C, proceed to **Auto Tensioner Removal** process.

If the flange is concave, proceed with the repair.

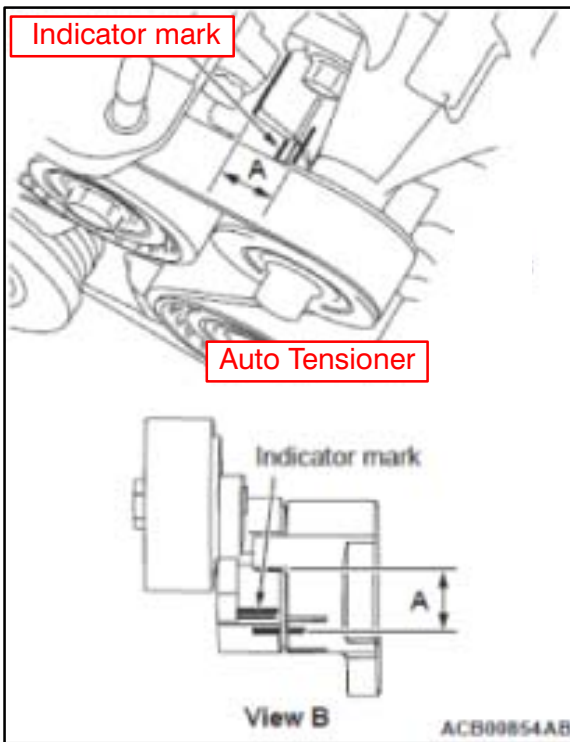
4. After the drive belt is reinstalled, rotate the crankshaft in a clockwise direction.
5. Using a mirror, make sure that the auto tensioner indicator mark is located within the “A” range, shown in this figure.

NOTE: When the auto tensioner indicator mark is located out of the range of “A in the following image”, the belt needs to be replaced because it is extended.
