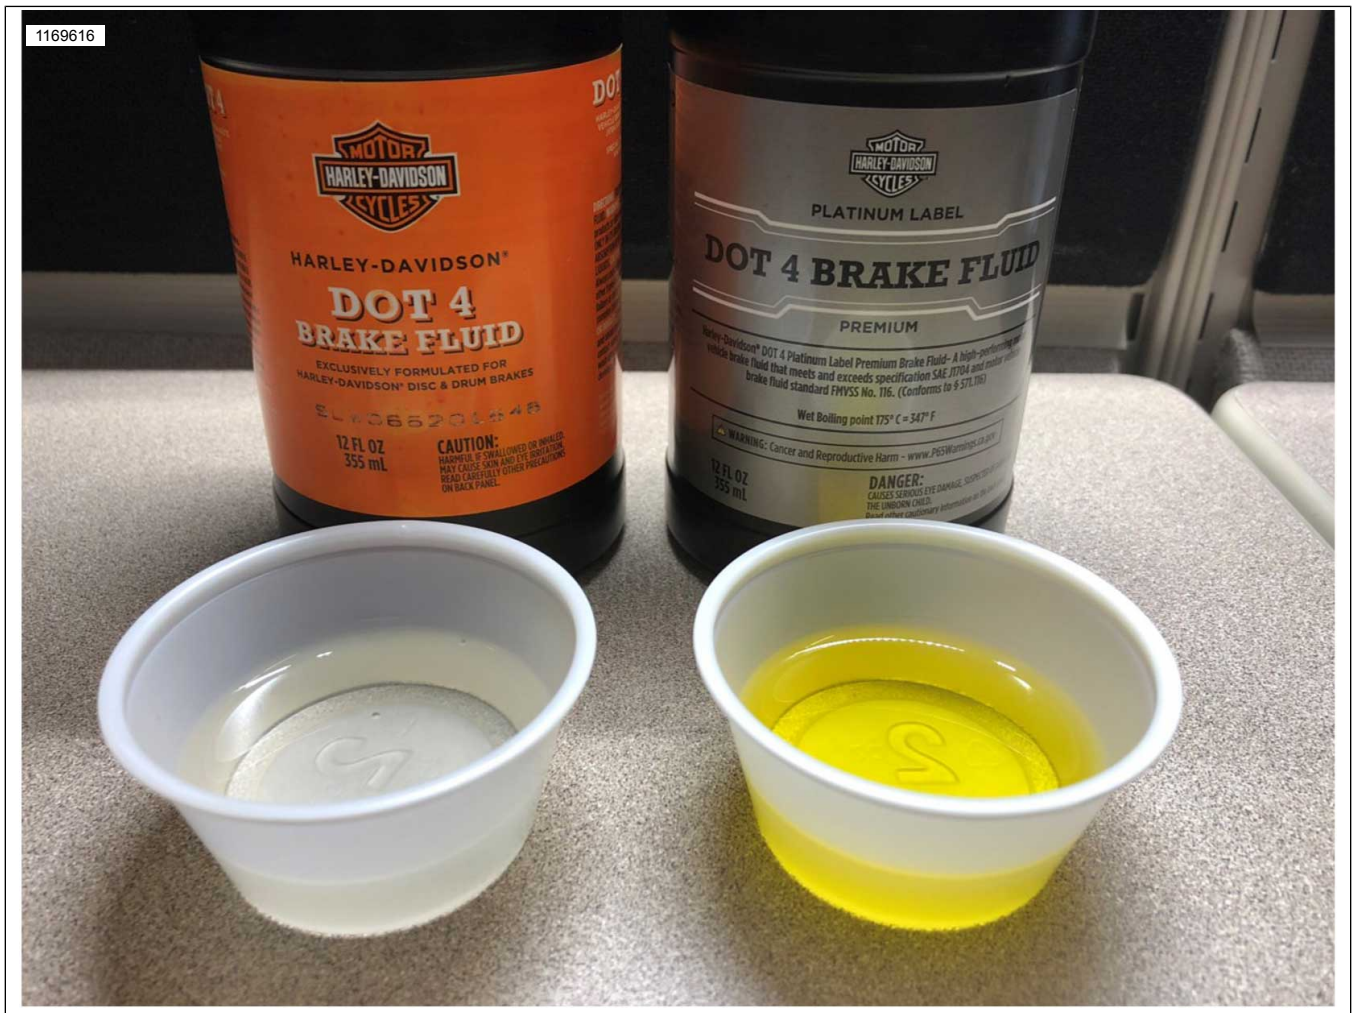
Figure 1. Dot 4 Brake Fluids

Refer to Figure 1. The difference in Platinum Label DOT 4 Brake Fluid chemistry will result in a noticeable color difference between the two fluids. The current DOT 4 BRAKE FLUID (99953-99A) is clear in color. The **new** fluid has a yellow tint to the fluid. Some may describe it as a yellow/green tint as well. These fluids are completely compatible and topping off one with the other, or slight mixing during the flushing process is not a problem.
