Dealer Service Instructions for:

Safety Recall U11 / NHTSA 18V-100 Brake Transmission Shift Interlock

The Brake Transmission Shift Interlock (BTSI) locking pin on about 180,400 of the above vehicles may become stuck in the open position. A BTSI locking pin stuck in the open position may allow the transmission to be shifted out of PARK and to any gear position without depression of the brake pedal and/or without the key in the ignition, if a key is applicable, or while the ignition is in the “OFF” mode. The ability to shift the transmission out of the PARK position while the ignition is in the “OFF” mode or without a key in the ignition or a brake pedal application, increases the risk for an unintended vehicle rollaway that may result in a vehicle crash or injury without prior warning.

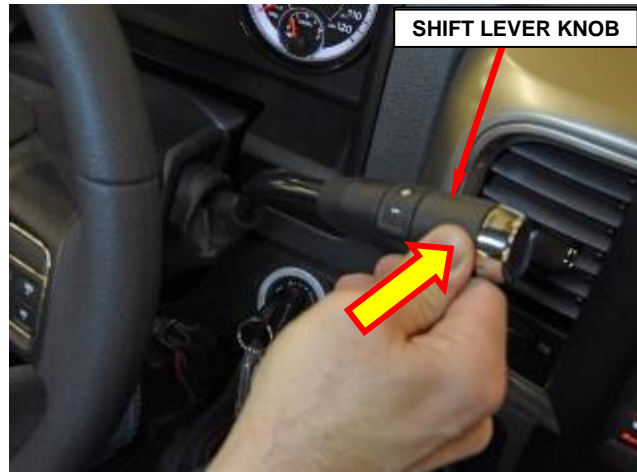
Figure 1 – Push Lightly On Shift Lever Knob Toward Instrument Panel To Feel BTSI Solenoid Pin Movement

5. Place your hand on the shift lever knob and push lightly on the shift lever toward the instrument panel. This will allow you to feel a click sensation from BTSI solenoid pin movement when the brake pedal is applied and released (Figure 1).

6. Listen for a click sound from the BTSI solenoid pin movement while also feeling for the corresponding click sensation in the shift lever when the brake is applied and released.

9. After five seconds of holding the brake pedal down, release the brake pedal while both listening and feeling for the click of the BTSI pin movement. The sound and feel of the BTSI pin movement should occur immediately within 0-2 seconds upon release of the brake pedal.

- If the BTSI pin could be heard and felt moving within 0-2 seconds, then the BTSI inspection process is complete and the gearshift bracket / BTSI assembly does not need to be replaced. Place the ignition switch in the “OFF” position then proceed to **Section C. Reprogram Body Control Module (BCM)**.

- If the BTSI pin could **not** be heard and felt moving within 0-2 seconds, then continue with **Step 10**.
