February 2018

Dealer Service Instructions for:

Safety Recall U11 / NHTSA 18V-100 Brake Transmission Shift Interlock

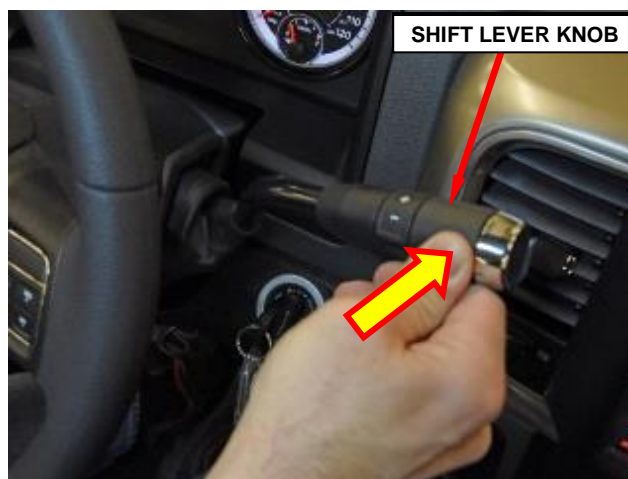
5. Place your hand on the shift lever knob and push lightly on the shift lever toward the instrument panel. This will allow you to feel a click sensation from BTSI solenoid pin movement when the brake pedal is applied and released (Figure 1).

Figure 1 – Push Lightly On Shift Lever Knob Toward Instrument Panel To Feel BTSI Solenoid Pin Movement
