HYUNDAI Technical Service Bulletin	GROUP RECALL	NUMBER 18-01-011-1
	DATE March, 2018	MODEL(S) Santa Fe Sport (AN) Santa Fe (NC)
SUBJECT: 2018 SANTA FE SPORT (AN) AND SANTA FE (NC) STEERING WHEEL INSPECTION AND REPLACEMENT (RECALL CAMPAIGN 173)

This TSB supersedes TSB# 18-01-011 and modifies the Warranty Information, Part Information and Inspection/Service Procedure sections.

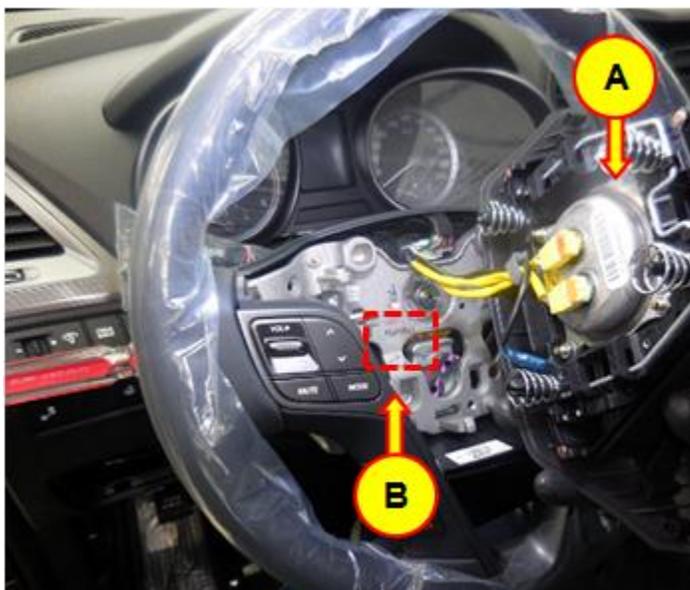
5. If the LOT No. (C) is '170609H', is illegible or does not have a Lot No., replace the steering wheel per the 2018 Santa Fe Sport or Santa Fe Service Manual (Steering System>Steering Wheel).

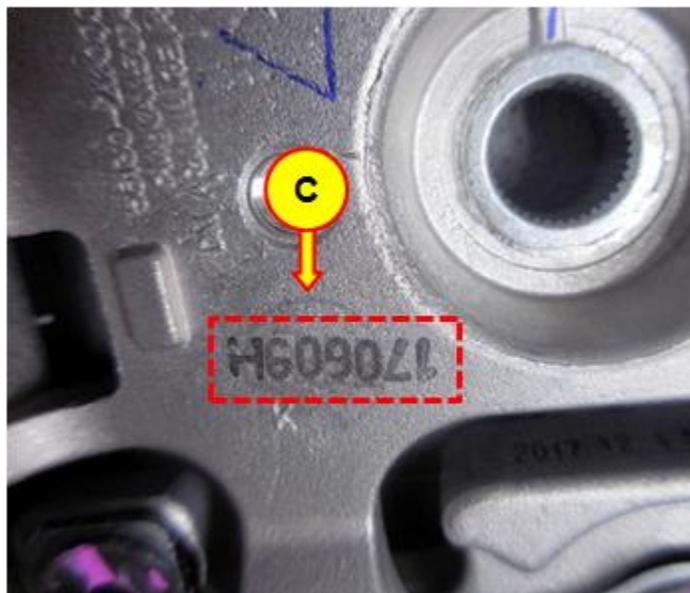
NOTE: Image of Lot No. above was rotated 180° from the actual position on the steering wheel for clarity.

6. If the LOT No. (C) is not '170609H', reinstall all removed parts in reverse order of removal and finish the service procedure.
