SAFETY RELATED RECALL

Recall Action
Number: N143v3

Subject: HVAC Inlet Door Linkage Disconnect	Publication No.: N143v3
	Model: Range Rover Velar (LY)
	Model Year: 2018
	Date of Issue: 22 August 2022

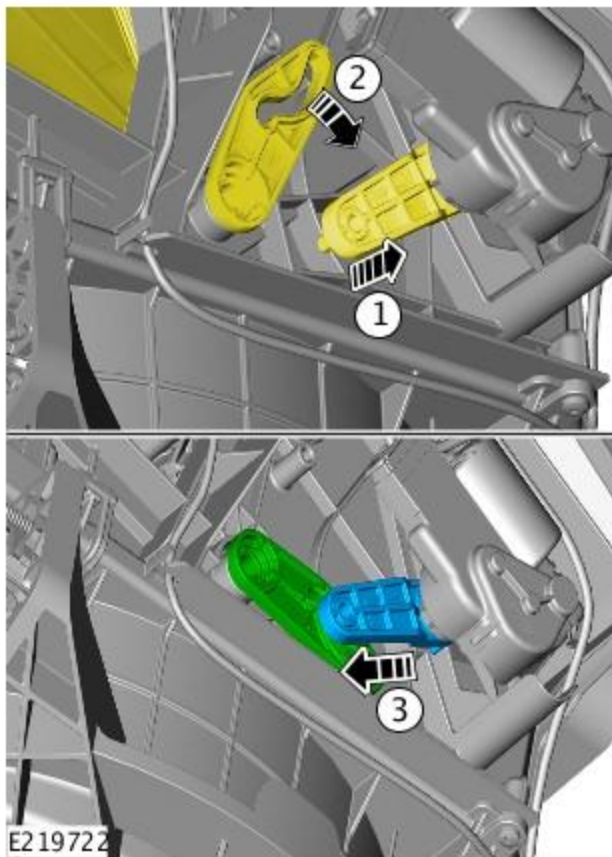
Install the recirculation blend door actuator lever arm into the recirculation door.

CAUTION: Do not use excessive force to install the actuator lever arm.

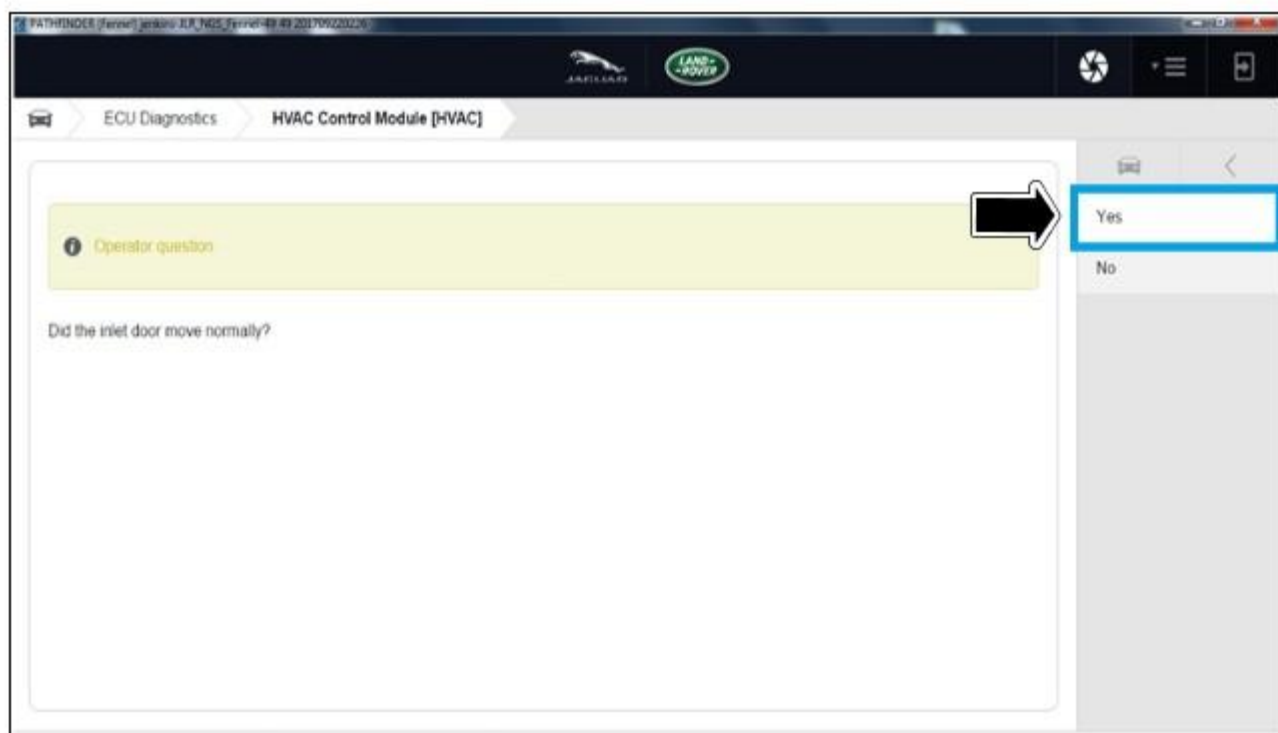
E221194

Continue with the JLR approved diagnostic equipment instruction until the following text appears on-screen.

- You are required to select 'Yes' in order to continue with the procedure, this will then update the [HVAC](#) software.

CAUTION: When selecting 'Yes' the software will be updated. This must be completed BEFORE replacing the lever arm'.

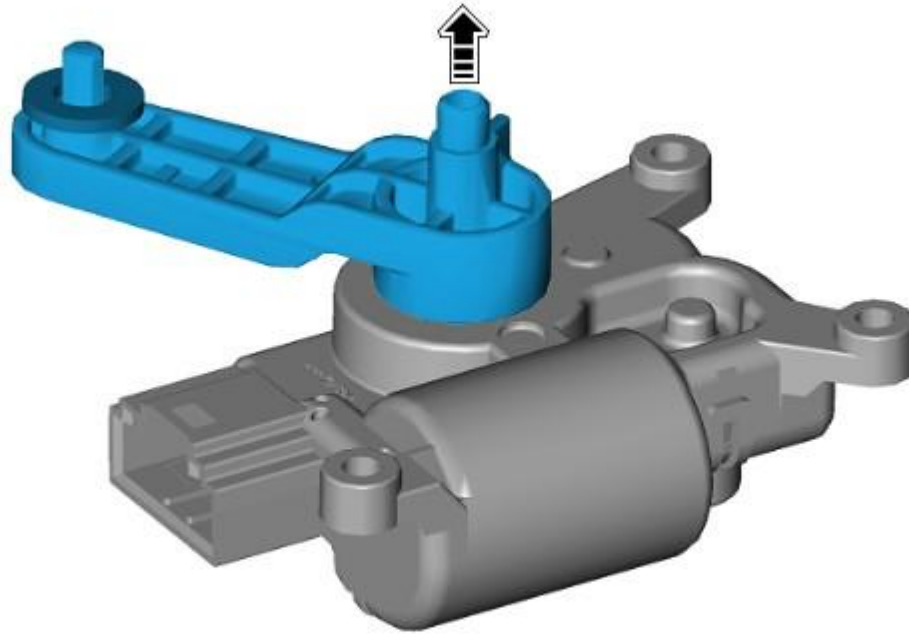
E221331

24. Remove the recirculation blend door actuator lever arm from the actuator.

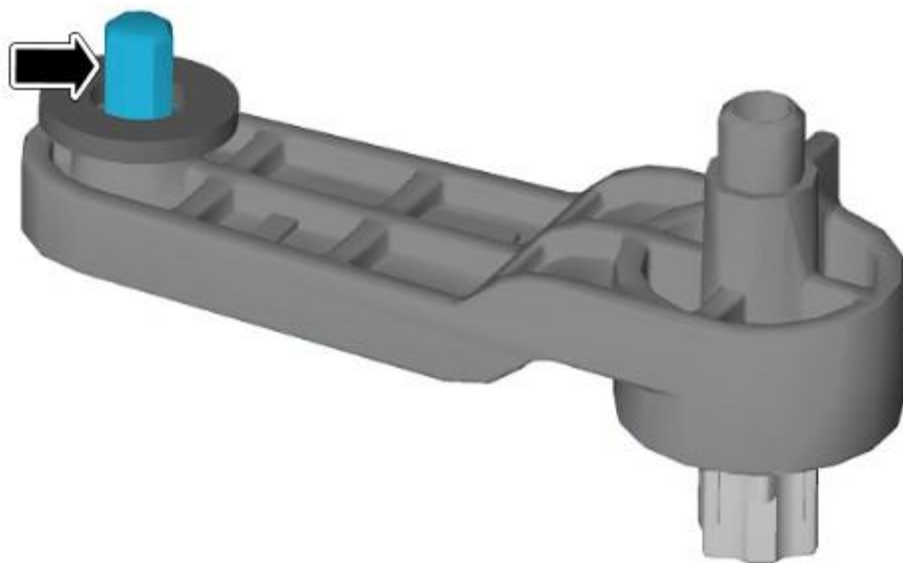
E221333

Apply the recovered grease to the new recirculation blend door actuator lever arm as shown.

CAUTION: This step must be completed using a clean glove.

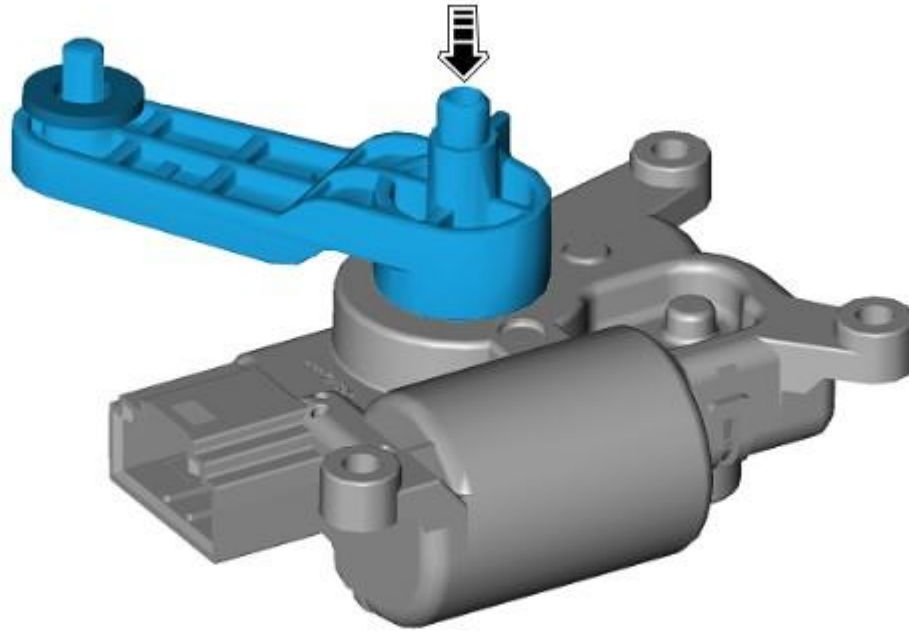
E221334

29. Install the recirculation blend door actuator lever arm to the actuator.

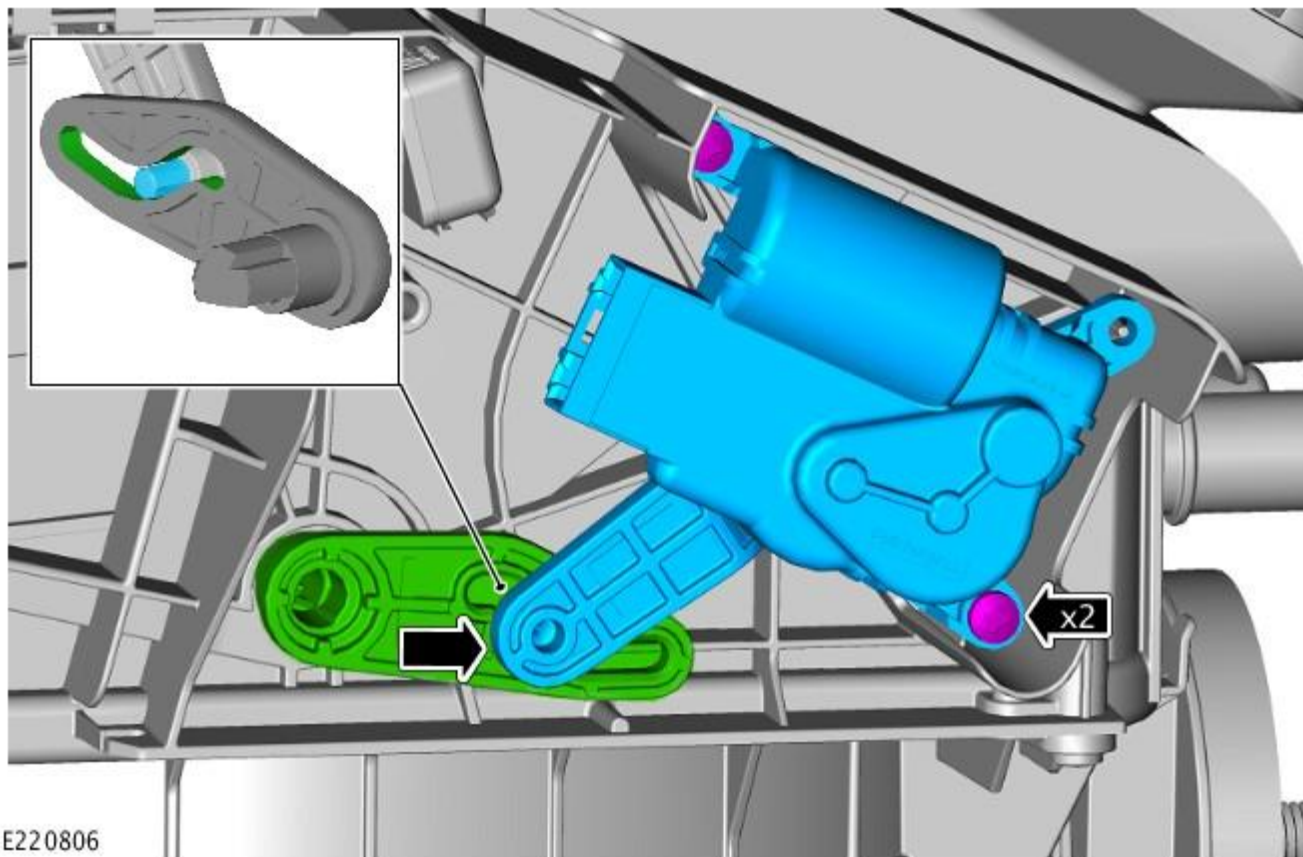
Install the recirculation blend door actuator.

- Install the recirculation blend door actuator retaining screws.
- Torque: **1.5 Nm**

Make sure when installing the recirculation blend door actuator the new retaining screws are used from the link arm kit.

Make sure the recirculation blend door actuator lever arm is located correctly into the blend door lever arm.
