SAFETY RECALL

AA9Q0 CONVENTIONAL VALVETRAIN
ADJUSTMENT SCREW LOCK NUT
INSPECTION/REPAIR

RECALL NO: AA9Q0
DATE: 3-15-2018
REFERENCE: QA-180314-N1

SUBJECT VEHICLES: 18MY-19MY Conventional Trucks equipped with a J08 engine

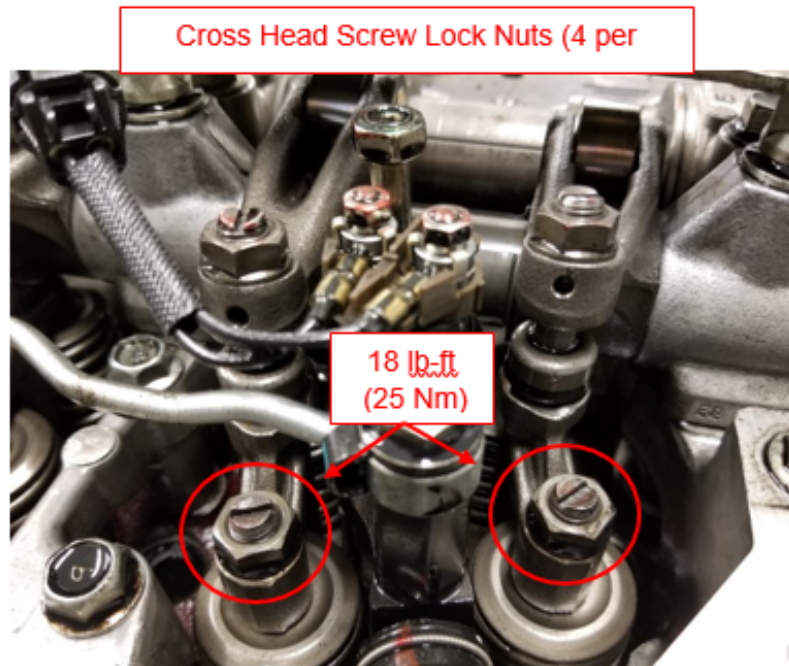
8. Inspect the 12 cross head screw lock nuts (2 nuts per cylinder). If any of the nuts have fallen off, attempt to locate the nut. **If the nut cannot be found, or engine damage is identified, contact Tech Assist for further direction.**

If all 12 nuts are present, use a torque wrench to check the torque of each of the 12 cross head screw lock nuts. Were any of the nuts found to be under tightened, below the specified torque?

Specified Torque: 18 lb-ft (25Nm)

Yes - Proceed to the Lash Adjustment Procedure

No - Proceed to the Assembly Procedure
