November 2018 FL766A-C NHTSA #18V-191 Transport Canada #18-190 REVISED NOTICE

#### Subject: Western Star Power Cable Studs

Models Affected: Specific Western Star 4700, 4900, 5700, and 6900 model vehicles manufactured September 12, 2016, through February 6, 2018.

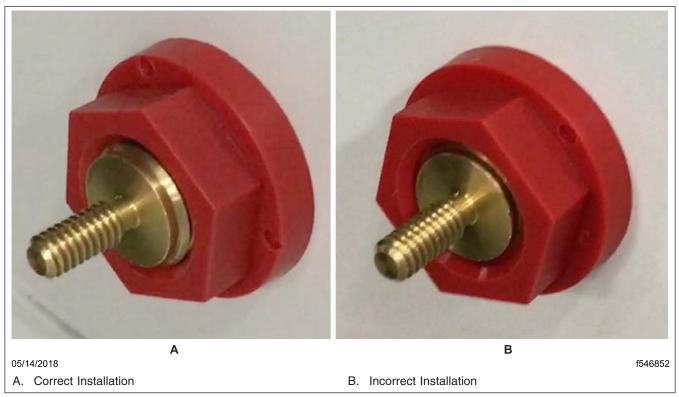
Fig. 3, Installation Inspection

- 1. Open the hood and locate the three or four power cable stud connectors on the front wall. See Fig. 1.
- 2. Pull back the covers on the power cable stud connectors. See Fig. 2. Inspect each cable stud to make sure at least one thread protrudes past the plastic nut. See Fig. 3 and Fig. 4.

If at least one thread does **NOT** protrude past the plastic nut, the installation is **INCORRECT**. Proceed to "Power Cable Stud Replacement."

If at least one thread protrudes past the plastic nut, the installation is **CORRECT** and the recall is complete. Continue with the next step.
