December 2018
FL766A-C
NHTSA #18V-191
Transport Canada #18-190
SECOND REVISED NOTICE

Subject: Western Star Power Cable Studs

Models Affected: Specific Western Star 4700, 4900, 5700, and 6900 model vehicles manufactured September 12, 2016, through February 6, 2018.

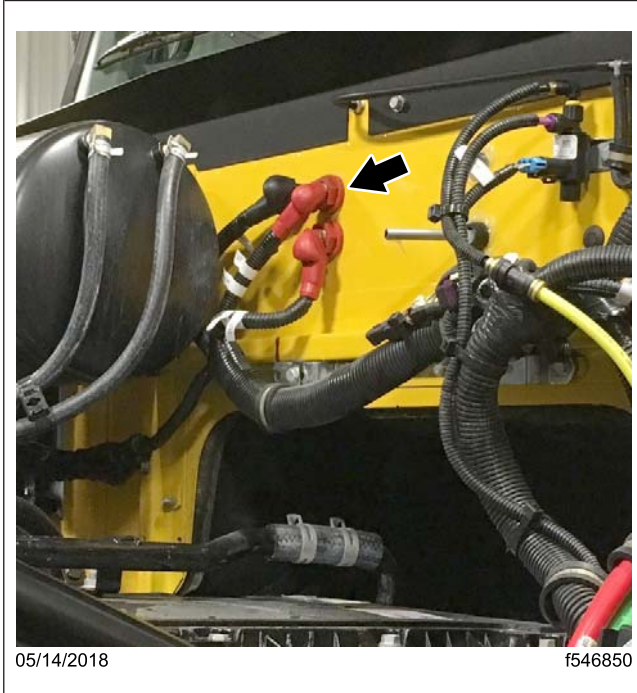
Fig. 1, Power Cable Stud Connector Location

1. Open the hood and locate the three or four power cable stud connectors on the front wall. See [Fig. 1](#).
2. Pull back the covers on the power cable stud connectors. See [Fig. 2](#). Inspect each cable stud to make sure at least one thread protrudes past the plastic nut. See [Fig. 3](#) and [Fig. 4](#).

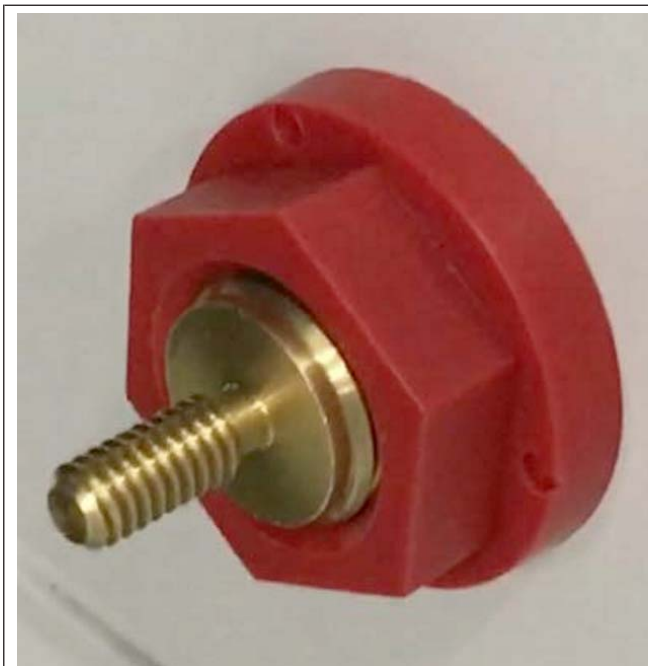
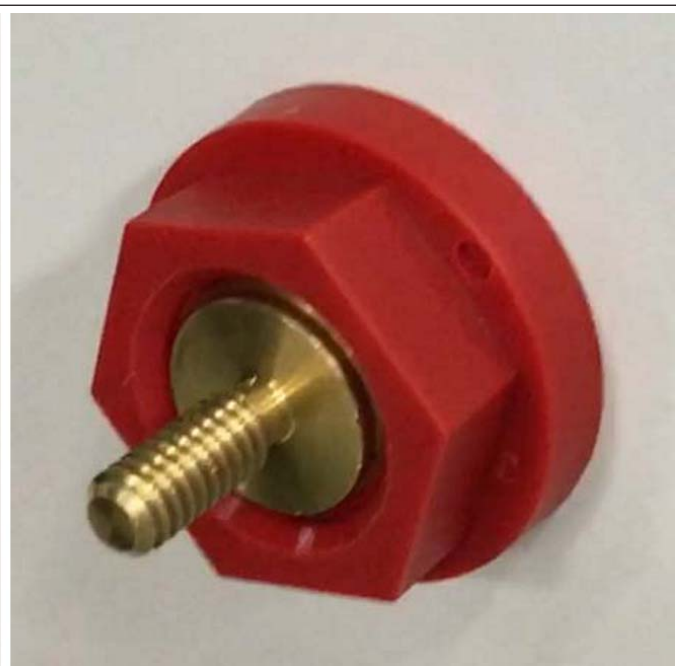
Fig. 3, Installation Inspection

If at least one thread does **NOT** protrude past the plastic nut, the installation is **INCORRECT**. Proceed to "Power Cable Stud Replacement."

If at least one thread protrudes past the plastic nut, the installation is **CORRECT** and the recall is complete. Continue with the next step.

05/14/2018
A. Correct Installation

B. Incorrect Installation

1. Disconnect the batteries.
2. If not already done, open the hood and locate the three or four power cable stud connectors on the front wall, and pull back the cover on the power cable stud connector. See [Fig. 1](#) and [Fig. 2](#).
3. For parts ordering, check to see if the power studs size is 1/4 inch or 3/8 inch.
4. Loosen the dash, and move it back enough to access the front-wall power terminals. Refer to *Western Star Workshop Manual*, **Section 60.06, Subject 110**.

6. Disconnect the cables from the terminals on the outside of the front wall.
7. Remove the plastic nuts and the studs.
8. Remove the old power cable studs and replace them with the new power cable studs.
9. Fully seat each stud in the square hole.
10. Tighten the plastic nuts 60 to 84 lbf-in (680 to 950 N-cm). Make sure at least one thread is exposed past the plastic nut.
11. Connect the cables to the terminals on the outside of the front wall.
12. Connect the cables to the terminals inside the cab.
13. Install the dash. Refer to *Western Star Workshop Manual*, **Section 60.06, Subject 110**.
14. Clean a spot on the base label (Form WAR259). Write the campaign number, FL766, on a blank red completion sticker (Form WAR260) to indicate the work has been completed and attach it to the base label.

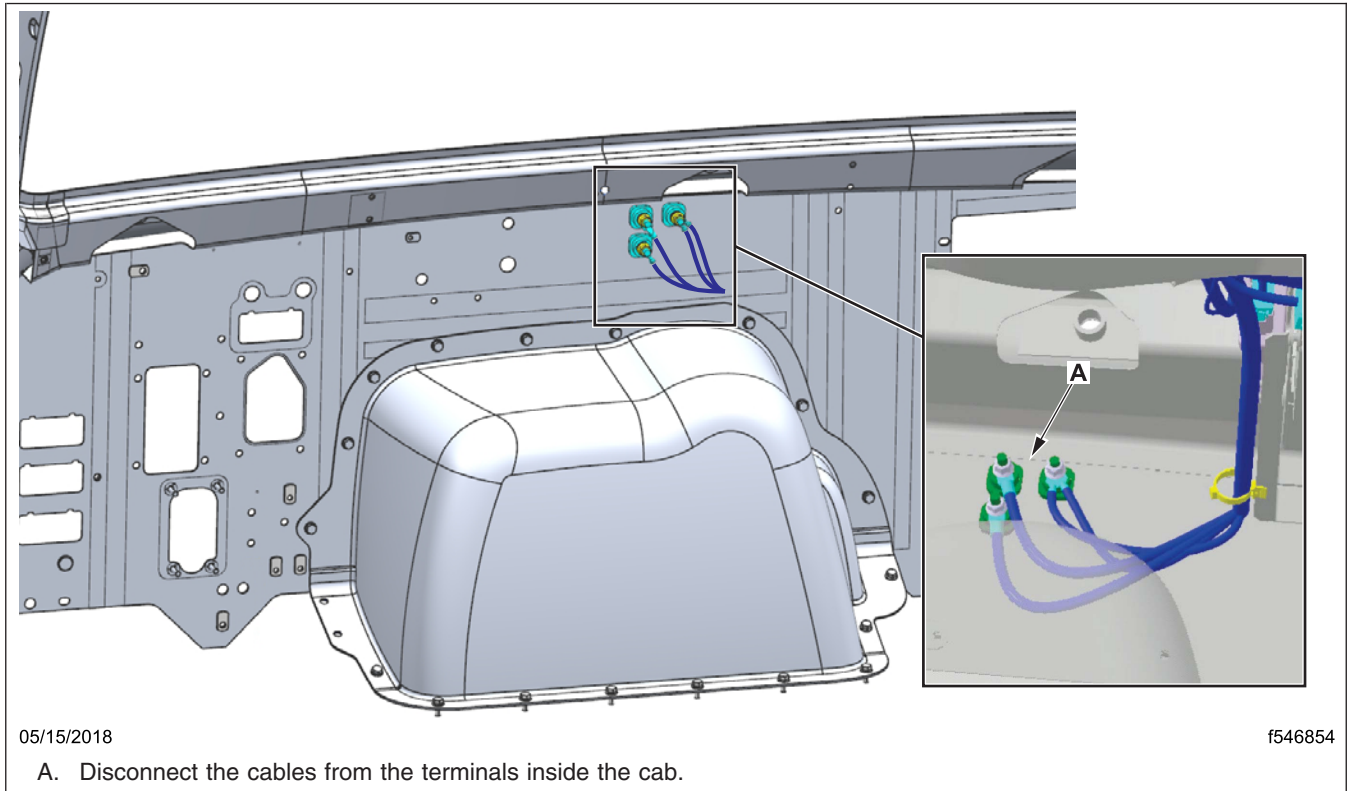
Fig. 5, Location of Front-Wall Power Terminals (inside the cab)

5. Disconnect the cables from the terminals inside the cab. See [Fig. 5](#)
