May 2018
INT FL766-01
NHTSA #18V-191
Transport Canada #18-190
INTERIM RECALL BULLETIN

Subject: Western Star Power Cable Studs

Models Affected: Specific Western Star 4700, 4900, 5700, and 6900 model vehicles manufactured September 12, 2016, through February 6, 2018.

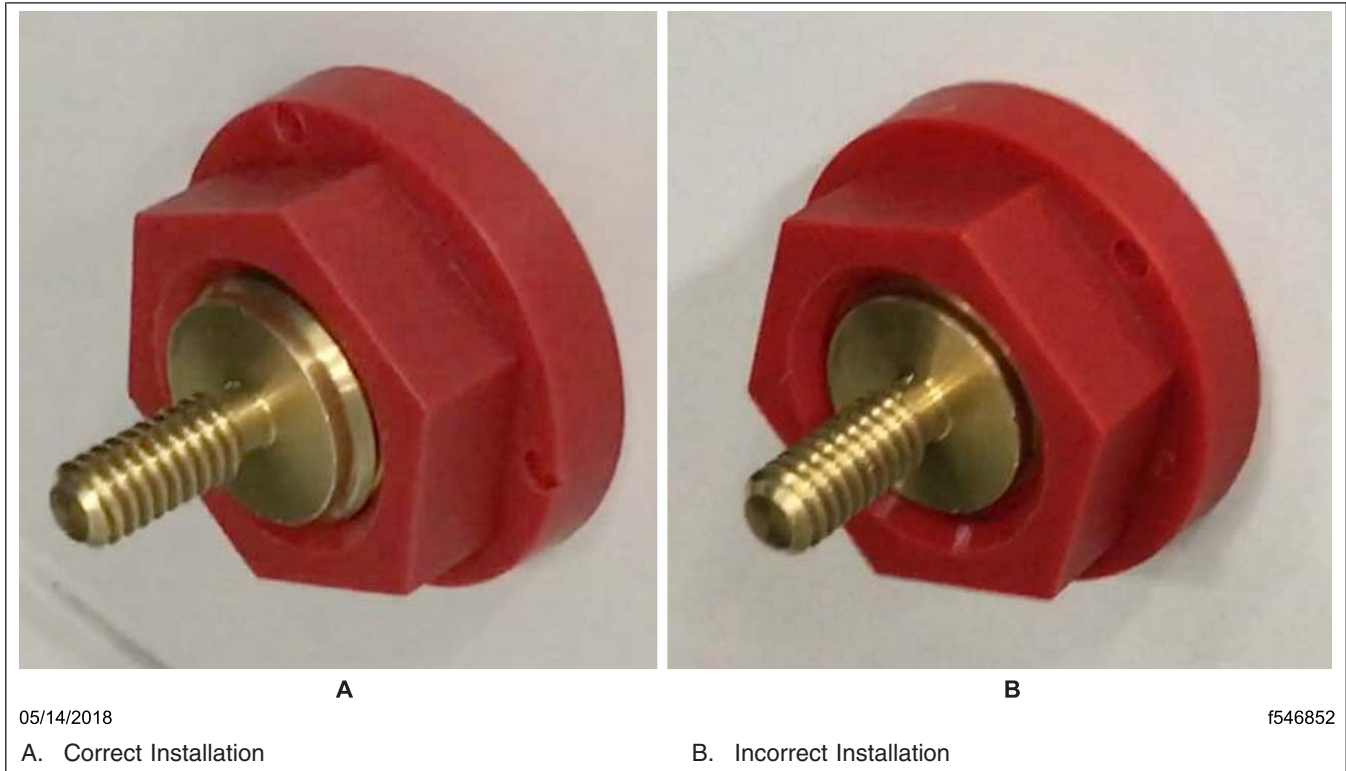
Fig. 3, Installation Inspection

1. Check OWL prior to performing the interim recall to ensure the vehicle is involved and the campaign has not been previously completed. **DO NOT** use a completion sticker for the interim inspection or repair. Attaching a recall completion sticker may prevent the customer from getting the final recall repair.
2. Park the vehicle on a level surface, shut down the engine, and set the parking brake. Chock the tires.
3. Open the hood and locate the three battery bulkhead connectors on the front wall. See [Fig. 1](#).
4. Pull back the covers on the battery bulkhead connectors. See [Fig. 2](#). Inspect the bulkhead studs to make sure at least one thread protrudes past the plastic nut. See [Fig. 3](#) and [Fig. 4](#).

If at least one thread does NOT protrude past the plastic nut, the installation is INCORRECT. Proceed to the next step.

*If at least one thread protrudes past the plastic nut, the installation is CORRECT and the recall is complete. Install the connector covers. **DO NOT** use a completion sticker for the interim inspection or repair. Attaching a recall completion sticker may prevent the customer from getting the final recall repair.*

8. Disconnect the cables from the terminals on the outside of the front wall.
9. Remove the plastic nuts and the studs.
10. Check the gaskets for damage. Replace damaged gaskets.
11. Fully seat the stud in the square hole.
12. Tighten the plastic nut 60 to 84 lbf-in (680 to 950 N-cm). Make sure at least one thread is exposed past the plastic nut.
13. Connect the cables to the terminals on the outside of the front wall.
14. Connect the cables to the terminals inside the cab.
15. Install the dash. Refer to the *Western Star Workshop Manual*, **Section 60.06, Subject 110**.
16. Once the interim repair is complete, **DO NOT** attach a completion sticker. Attaching a completion sticker may prevent the customer from getting the final recall repair.
