MODEL:	TYPE:	SECTION/GROUP:	DATE:
J4500 Series	Field Change Program	07- Electrical	April 18, 2018

Ref. MCI NHTSA Recall No.:18V-223

Ref. MCI Transport Canada Recall No.:2018-170

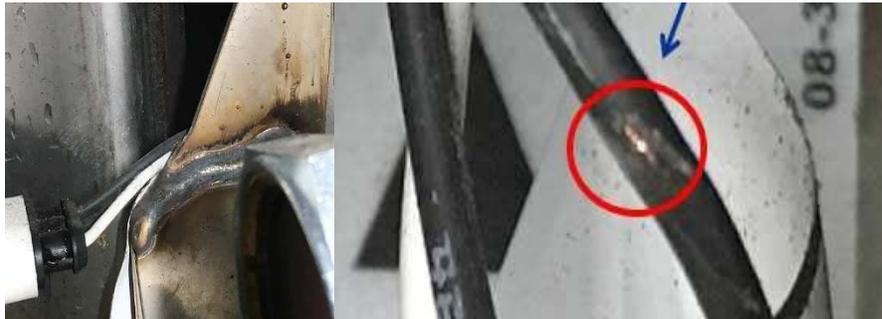
Carefully inspect each of the wires for any damage due to rubbing on the sharp edge of the coolant surge tank. If any damage is found as shown in the picture below, proceed to step 5.2. If during the inspection no damage is observed, proceed to step 5.3.

Identify the damaged wire and unload it from the connector using the correct terminal release tool (refer to the appendix for more details). Place a piece of shrink tube (PN 1911-1465) over the damaged portion of the wire, and ensure that the damaged area is covered on both sides by at least a ¼" (6.35 mm) of heat shrink.
