MODEL:	TYPE:	SECTION/GROUP:	DATE:
J4500 Series	Field Change Program	07- Electrical

Ref. MCI NHTSA Recall No.:18V-XXX

Ref. MCI Transport Canada Recall No.:2018-170

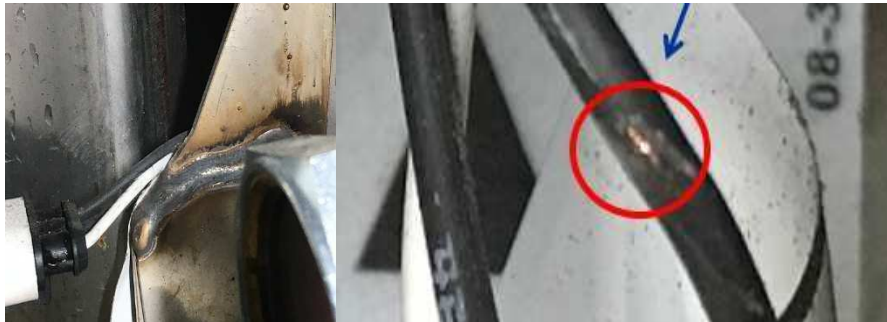
Motor Coach Industries (“MCI”) has become aware that the wiring of the left hand tail light harness may come in contact with the coolant surge tank, potentially causing the engine low coolant light in the instrument panel to flash, and/or shorting out the tail light circuit and causing the left hand tail lights not to function. The low coolant light flashing is a false indication to the operator that a low coolant issue may exist.

The left hand tail light wires were routed too close to the coolant surge tank support bracket.

Carefully inspect each of the wires for any damage due to rubbing on the sharp edge of the coolant surge tank. If any damage is found as shown in the picture below, proceed to step 5.2. If during the inspection no damage is observed, proceed to step 5.3.

Identify the damaged wire and unload it from the connector using the correct terminal release tool (refer to the appendix for more details). Place a piece of shrink tube (PN 1911-1465) over the damaged portion of the wire, and ensure that the damaged area is covered on both sides by at least a 1/4" (6.35 mm) of heat shrink.
