Safety Recalls

Codes: 1902 / 19N4

Subject	After-Run Coolant Pump
Release Date	February 15, 2018
REVISION SUMMARY	<p>1902 – Updated claiming and work instructions to allow Pierburg pump installation on vehicles built after December 31 2012.</p> <p>19N4 – No changes.</p>
IMPORTANT! DO NOT PERFORM BOTH Safety Recall 1902 and Safety Recall 19N4	<p>All vehicles in Safety Recall 1902 are also in Safety Recall 19N4.</p> <p><u>Only one recall should be completed on each vehicle.</u></p> <ul style="list-style-type: none"> ➤ Perform Safety Recall 1902 only if a replacement after-run coolant pump is available. ➤ Perform Safety Recall 19N4 only if a replacement after-run coolant pump is <u>NOT</u> available. <p>Enter your recall claim as soon as possible. A SAGA claim for one of these recalls will automatically close the other. This automatic closure is normally completed within one week but may take up to two weeks.</p>
Affected Vehicles	<p>U.S.A.: Certain 2012-2017 MY Audi vehicles with a 2.0L TFSI gasoline engine</p> <p>CANADA: Certain 2013-2017 MY Audi vehicles with a 2.0L TFSI gasoline engine</p> <p><i>Check Campaigns/Actions screen in Elsa on the day of repair to verify that a VIN qual

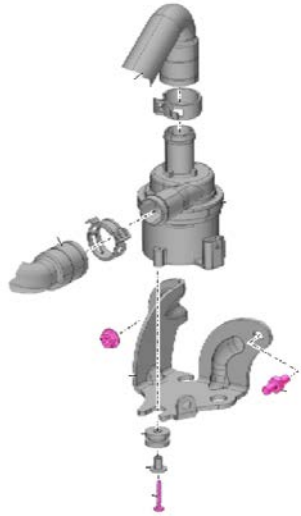
After-run Coolant Pump Identifier

- Pierburg
- Buehler

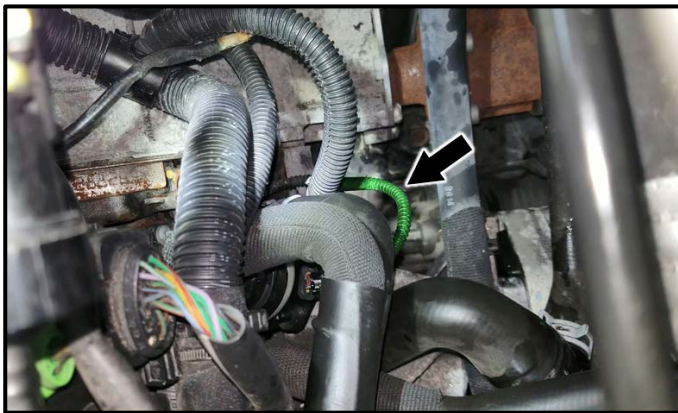
Installing new after-run coolant pump -V51-:

Due to the new location of the connector on the new pumps, the after-run coolant pump wiring harness <arrow> may have to be routed so it does not come into contact with the pump coolant hose.
