Safety Recall

Code: 1902

Audi

Subject	After-Run Coolant Pump																		
Release Date	April 26, 2019																		
REVISION SUMMARY	Claiming and work instructions have been updated to allow the “K” or “H” index after-run coolant pump for Criteria 05 and 06 vehicles.																		
Affected Vehicles	<p>U.S.A.: Certain 2012-2017 MY Audi vehicles with a 2.0L TFSI gasoline engine</p> <p>CANADA: Certain 2013-2017 MY Audi vehicles with a 2.0L TFSI gasoline engine</p> <p><i>Check Campaigns/Actions screen in Elsa on the day of repair to verify that a VIN qualifies for repair under this action. Elsa is the <u>only</u> valid campaign inquiry & verification source.</i></p> <ul style="list-style-type: none"> ✓ Campaign status must show “open.” ✓ If Elsa shows other open action(s), inform your customer so that the work can also be completed at the same time the vehicle is in the workshop for this campaign. 																		
Problem Description	In certain vehicles with a 2.0L TFSI gasoline engine, the electric (after-run) coolant pump may short circuit and/or overheat, potentially leading to a vehicle fire.																		
Corrective Action	Install a new electric (after-run) c

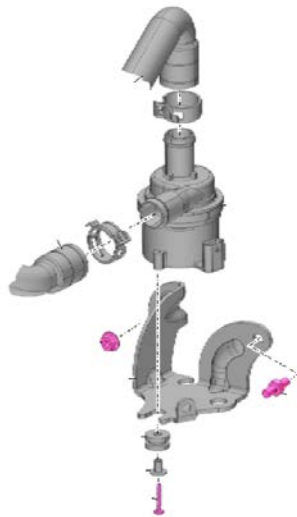
After-run Coolant Pump Identifier

1. Pierburg
2. Buehler

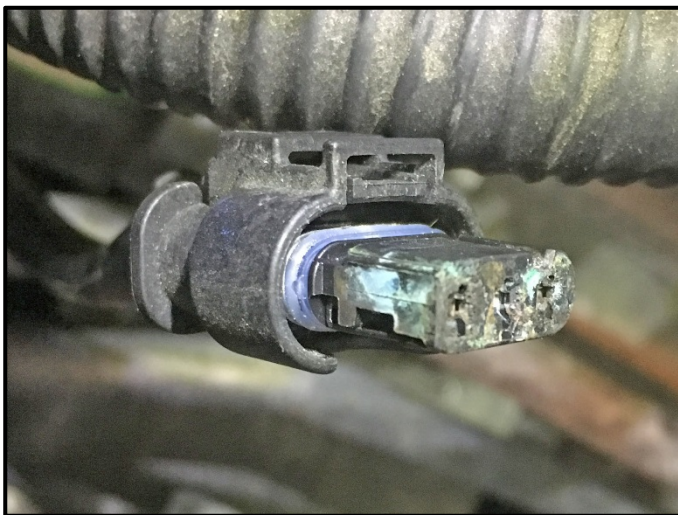
Inspect connector to after-run coolant pump -V51-:

- Check the wiring connector AND the coolant pump connector housing for the following:
 - Signs of overheating
 - Pin corrosion
 - Coolant intrusion
- The wiring connector housing, pins and seals must be replaced if the connector housing is found damaged at the time of repair.

Qty.	Part Number	Part Description
1	000.979.940	Butt connector for 0.5 mm wire
2	000.979.941	Butt connector for 1.0 mm wire
1	000.979.034.E	0.5 mm wire
1	000.979.159.E	1.0 mm wire
3	3C0.972.741	Wire seal
1	4H0.973.703	Connector housing

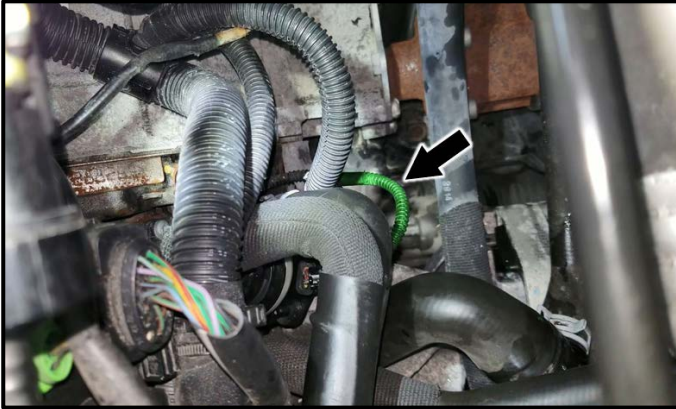
Due to the new location of the connector on the new pumps, the after-run coolant pump wiring harness <arrow> may have to be routed so it does not come into contact with the pump coolant hose.

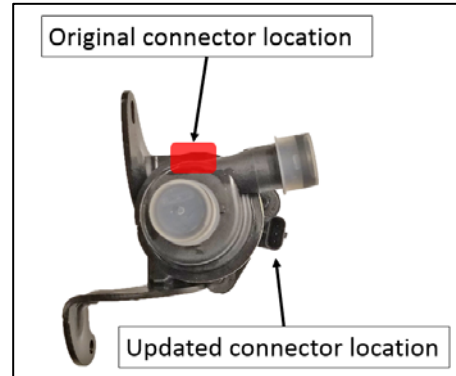
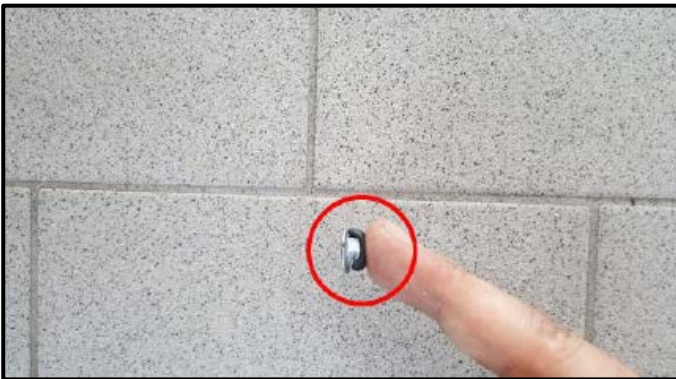
When installing nut <2>, a swivel socket may not clear the coolant hose fitting.

- Attach securing nut to index finger using some sealant cord ("dum-dum").
- Position securing nut on stud with index finger.
- If necessary, hold securing nut from above with a flat-bladed screwdriver and at the same time screw on securing nut with index finger until a socket can be used on the nut.
