Safety Recall

Code: 19N4

NHTSA: 18V229

**Subject: Safety Recall 19N4 – Electric (After Run) Coolant Pump
Certain 2012-2017 Model Year Audi Vehicles with a 2.0L TFSI Gasoline Engine**

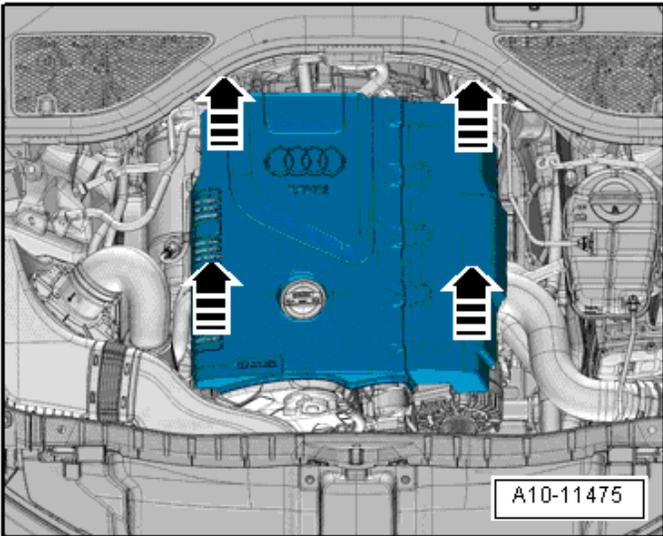
- Carefully pull the engine cover off the ball pins one after the other in direction of <arrows>. Do not pull sharply on the engine cover or pull it to one side.
