Safety Recalls

Codes: 19O2 / 19N4

<p>Subject After-Run Coolant Pump</p> <p>Release Date December 13, 2018</p>	
<p>IMPORTANT!</p> <p><u>DO NOT PERFORM BOTH</u></p> <p>Safety Recall 19O2 and Safety Recall 19N4</p>	<p>All vehicles in Safety Recall 19O2 are also in Safety Recall 19N4.</p> <p><u>Only one recall should be completed on each vehicle.</u></p> <ul style="list-style-type: none"> ➤ Perform Safety Recall 19O2 only if a replacement after-run coolant pump is available. ➤ Perform Safety Recall 19N4 only if a replacement after-run coolant pump is <u>NOT</u> available. <p>Enter your recall claim as soon as possible. A SAGA claim for one of these recalls will automatically close the other. This automatic closure is normally completed within one week but may take up to two weeks.</p>
<p>Affected Vehicles</p>	<p>U.S.A.: Certain 2012-2017 MY Audi vehicles with a 2.0L TFSI gasoline engine</p> <p>CANADA: Certain 2013-2017 MY Audi vehicles with a 2.0L TFSI gasoline engine</p> <p><i>Check Campaigns/Actions screen in Elsa on the day of repair to verify that a VIN qualifies for repair under this action. Elsa is the <u>only</u> valid campaign inquiry & verification source.</i></p> <ul style=

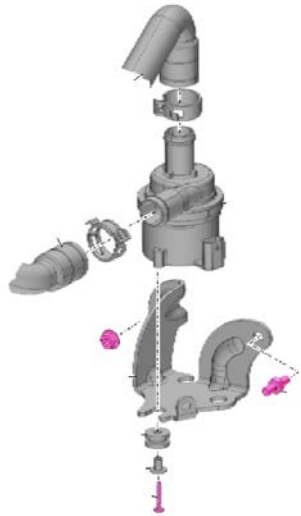
After-run Coolant Pump Identifier

1. Pierburg
2. Buehler

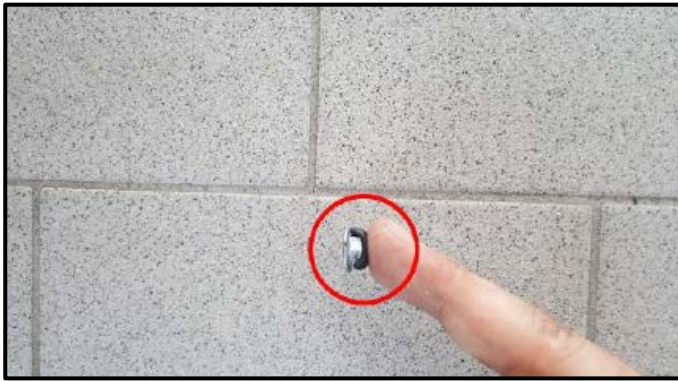
When installing nut <2>, a swivel socket may not clear the coolant hose fitting.

- Attach securing nut to index finger using some sealant cord (“dum-dum”).
- Position securing nut on stud with index finger.
- If necessary, hold securing nut from above with a flat-bladed screwdriver and at the same time screw on securing nut with index finger until a socket can be used on the nut.
