Dealer Service Instructions for:

Safety Recall U27 / NHTSA 18V-231

Under Body Ladder Rail

2018 (JK) Jeep® Wrangler

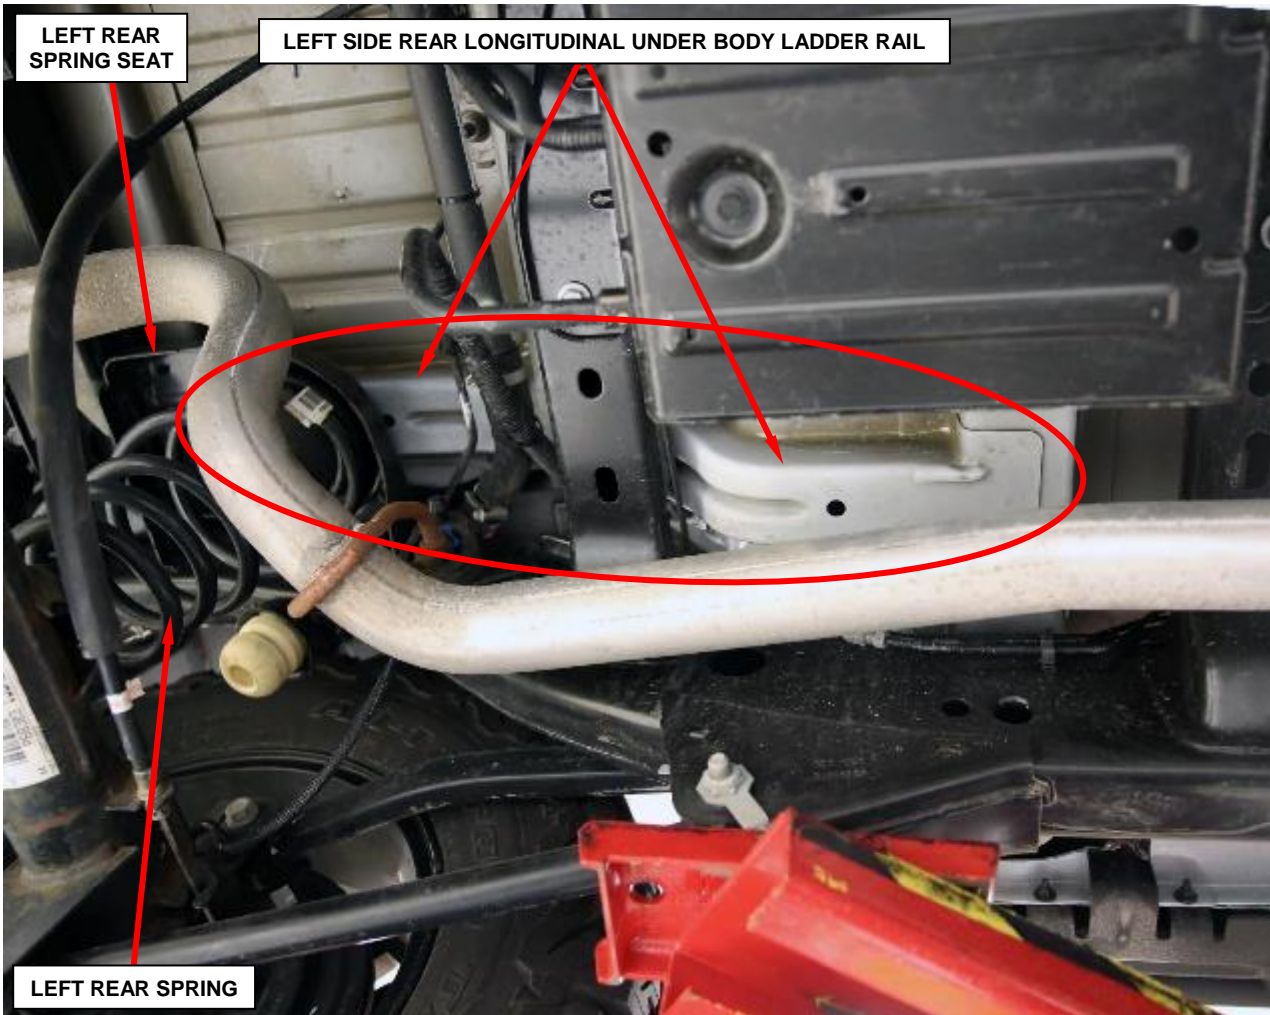
Figure 1 – Left Side Rear Longitudinal Under Body Ladder Rail Location

NOTE: Figure 1 is only for identifying the location of the left side rear longitudinal under body ladder rail. Proceed to Section A. Date Code Inspection for determining if the vehicle contains a suspect part.

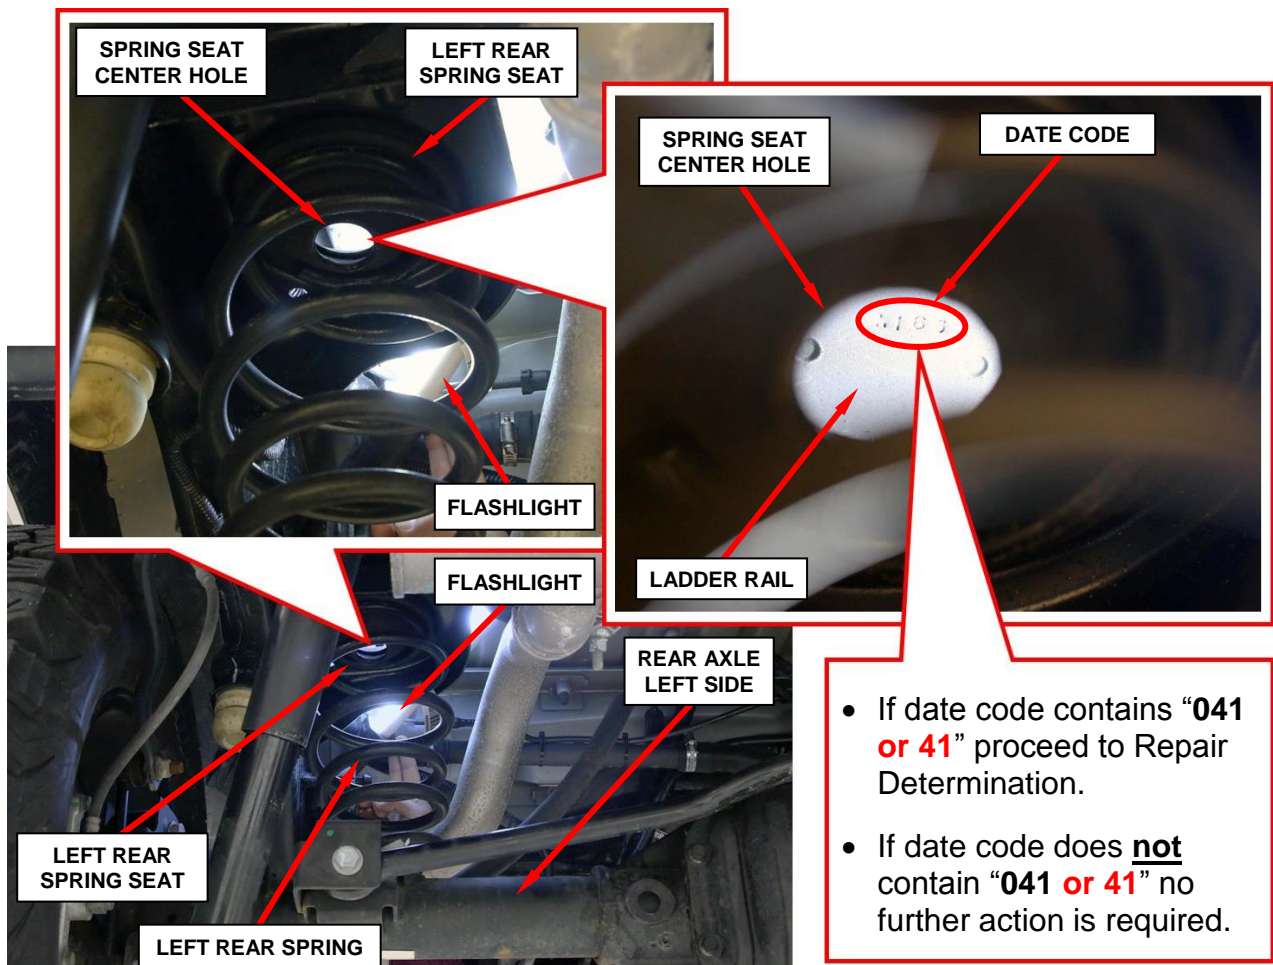
Figure 2 – Inspect Date Code - Left Side Rear Longitudinal Under Body Ladder Rail

1. Raise and support the vehicle.
2. While using a flashlight or bore scope, stand behind the rear axle to view the left side rear longitudinal under body ladder rail above the left rear spring seat. The date code can be viewed through the left rear spring seat center hole (Figure 2). Locate the date code stamped on the ladder rail and record date code numbers only. **Ignore any preceding letters, read the numbers only.**
 - If the date code **is** 041 or 41, proceed to **Step 3**.
 - If date code is **not** 041 or 41, lower the vehicle and return to the customer. Claim LOP 23-U2-71-81 for inspection.
 - If the date code cannot be read, contact your area Technical Advisor.

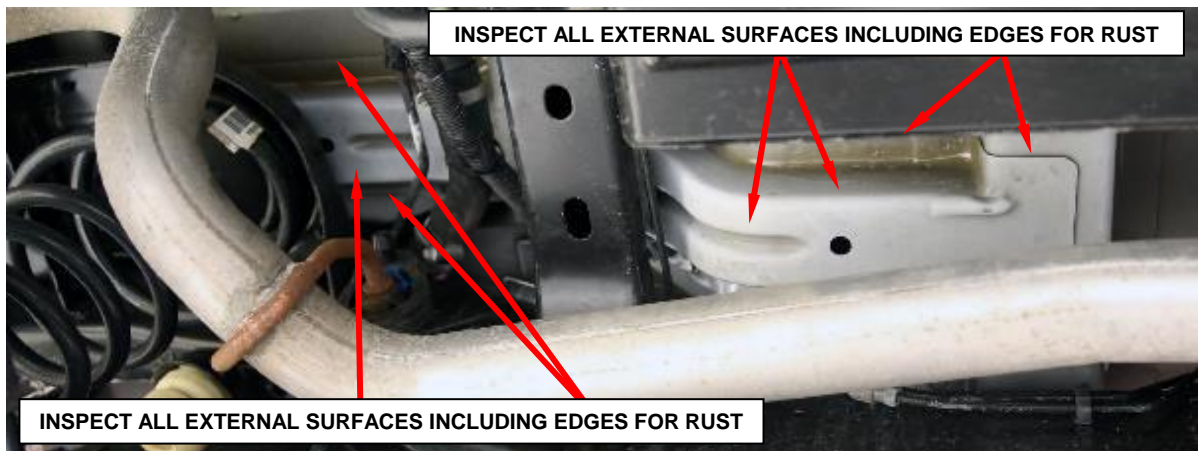
Figure 4 – Inspect Ladder Rail External Surfaces and Edges for Rust

- 2. Inspect the left side rear longitudinal under body ladder rail for any visible red rust. Visually inspect the external surfaces and edges for rust (Figure 4). Use a lighted borescope inserted through the existing holes in the ladder rail to inspect the internal cavity surfaces and edges for rust (Figure 5).
 - If red rust is visible, the vehicle is not repairable and must be repurchased. Claim LOP 23-U2-71-82 for Repair Determination.
 - If red rust is **not** visible, proceed to **Step 3**.

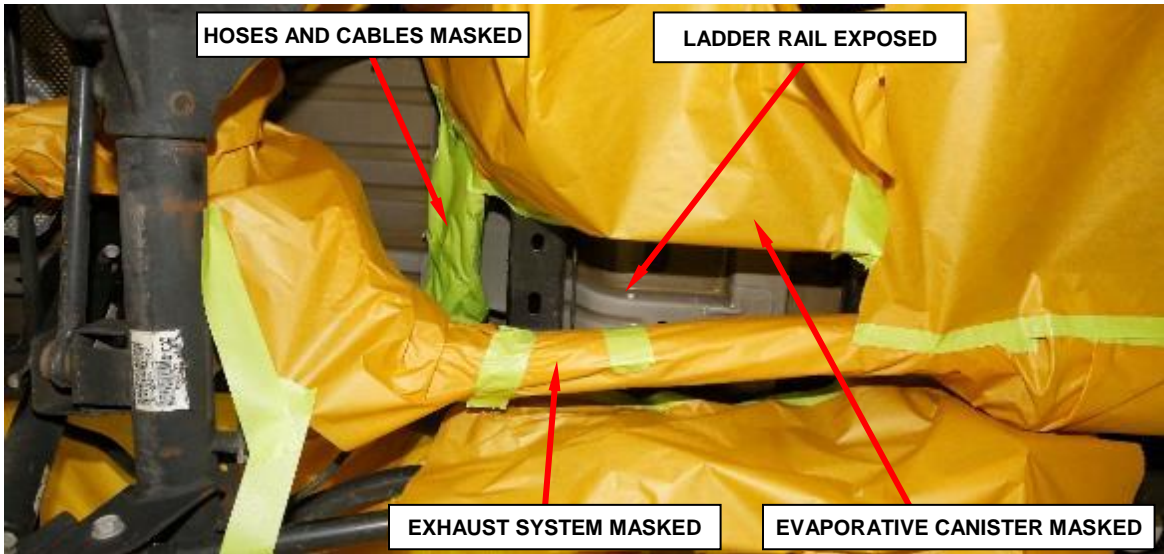
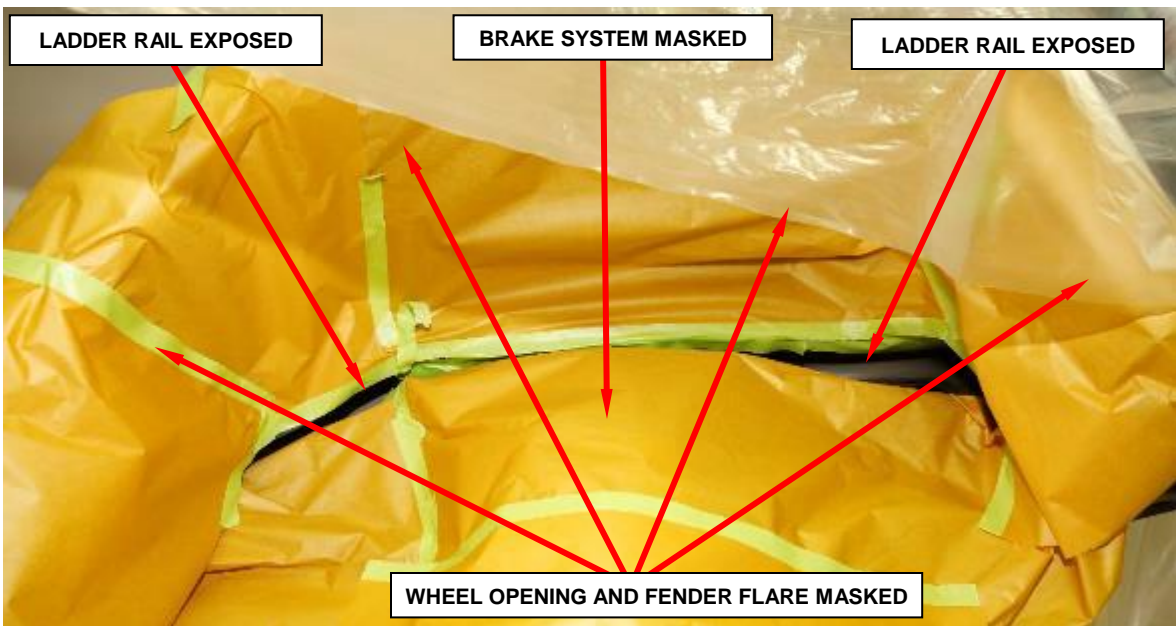
Figure 6 – Mask Underbody Components

Figure 7 – Mask Wheel Opening Components

- 2. Carefully mask off any surfaces which could be adversely affected if coated with bedliner material such as exhaust system, drive shaft, hose connections, evaporative emissions canister, brake system components, painted vehicle body, etc. Bedliner material hardens very quickly and cannot be easily removed from surfaces once applied (Figures 6 and 7).

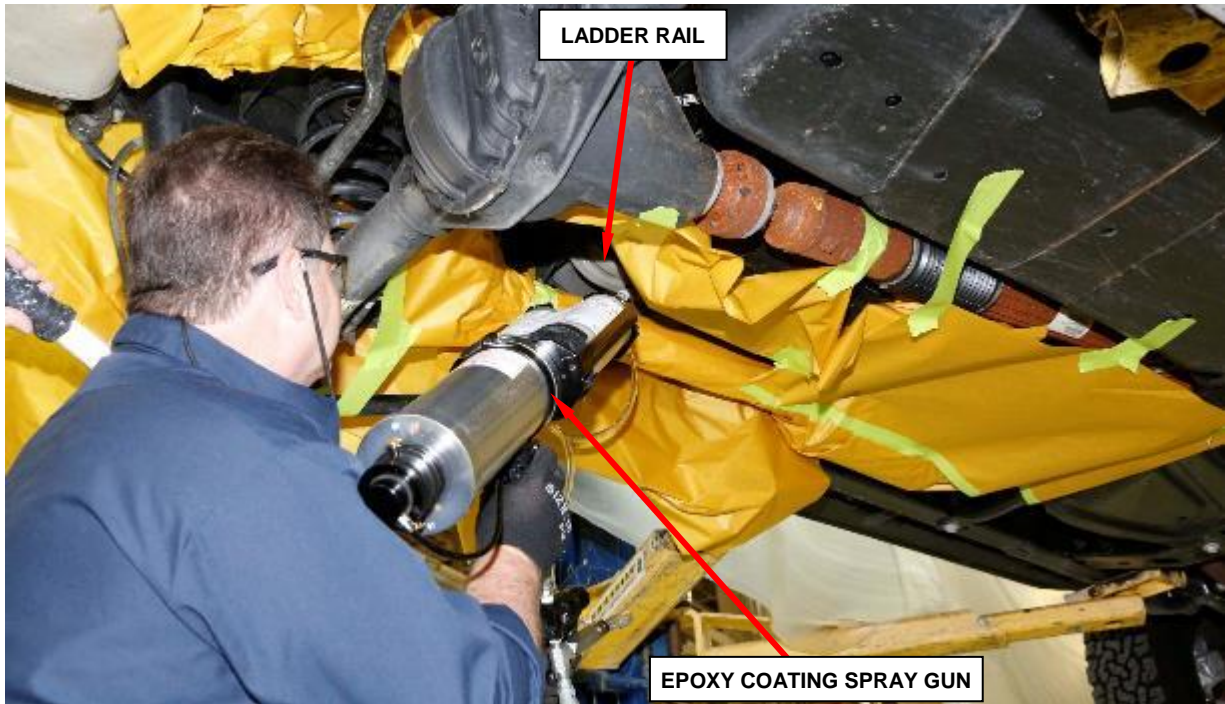
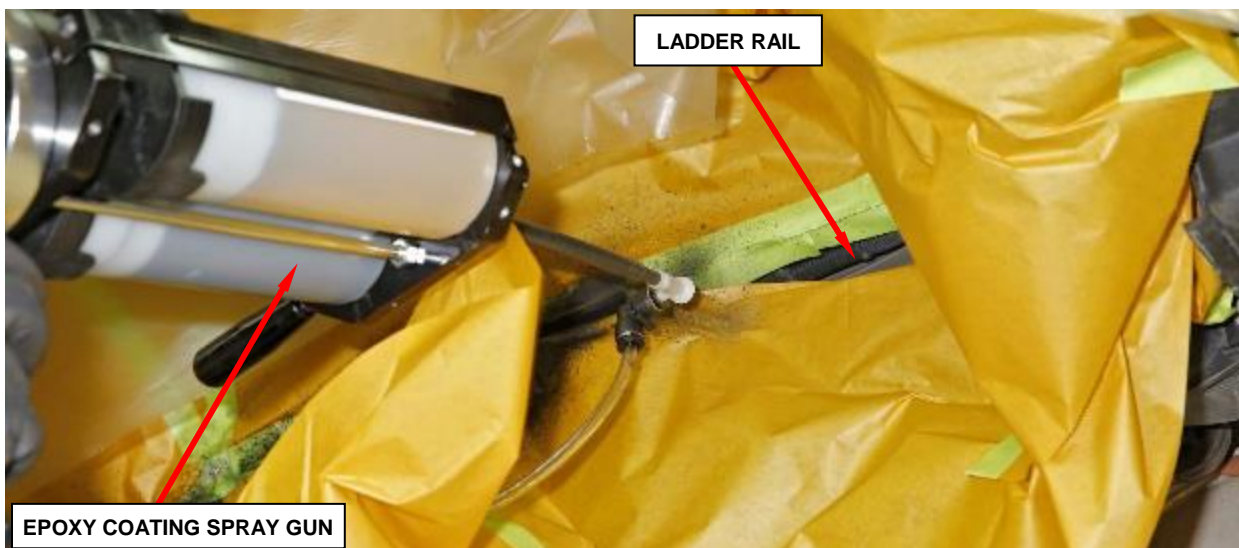
Figure 9 – Apply Epoxy Coating to Ladder Rail from Underside of Vehicle

Figure 10 – Apply Epoxy Coating to Ladder Rail through Wheelhouse Opening

5. Use the epoxy coating spray gun with black epoxy coating cartridge to the epoxy coating to all the accessible surfaces of the left side rear longitudinal under body ladder rail from underside of vehicle and inside wheelhouse (Figures 9 and 10).
