Safety Recall Code: 69Q8

TAKATA Driver Frontal Airbag Inflator

April 19, 2018

U.S.A. & CANADA: Certain 2006-2007 MY Volkswagen Passat Sedan & Passat Wagon vehicles equipped with a Takata driver frontal airbag

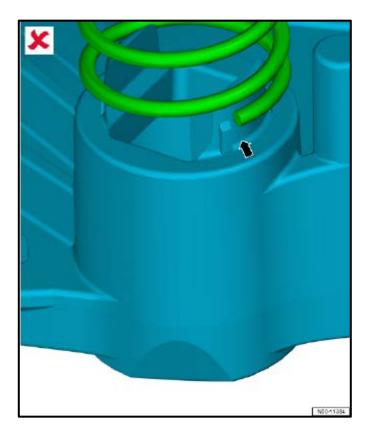
- If one of the springs is damaged or has been lost, it can be replaced with a spring from the bag of spares included.
- Note the examples shown for reference of proper spring seating.
- Spring seated **incorrectly** <arrow>.

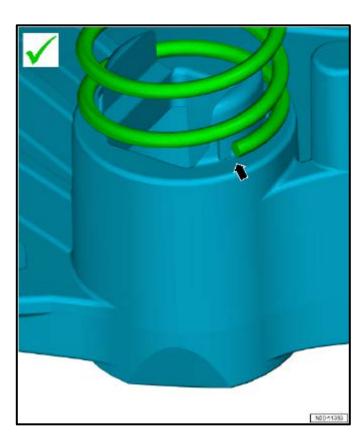
Spring seated correctly <arrow>.

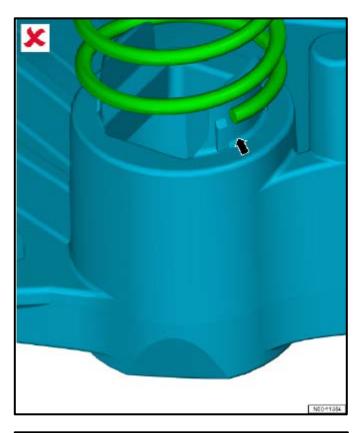
- If one of the springs is damaged or has been lost, it can be replaced with a spring from the bag of spares included.
- Note the examples shown for reference of proper spring seating.
- Spring seated incorrectly <arrow>.

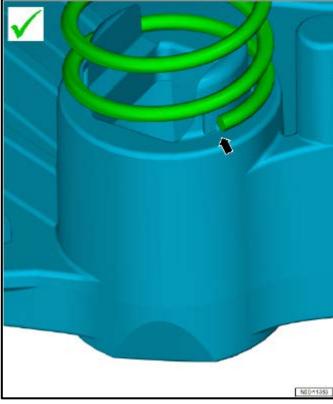
• Spring seated correctly <arrow>.
