Safety Recall Code: 69Q8

TAKATA Driver Frontal Airbag Inflator

July 21, 2018

U.S.A. & CANADA: Certain 2006-2007 MY Volkswagen Passat Sedan & Passat Wagon vehicles equipped with a Takata driver frontal airbag

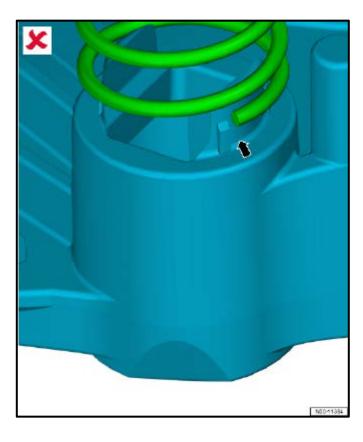
- If one of the springs is damaged or has been lost, it can be replaced with a spring from the bag of spares included.
- Note the examples shown for reference of proper spring seating.
- Spring seated **incorrectly** <arrow>.

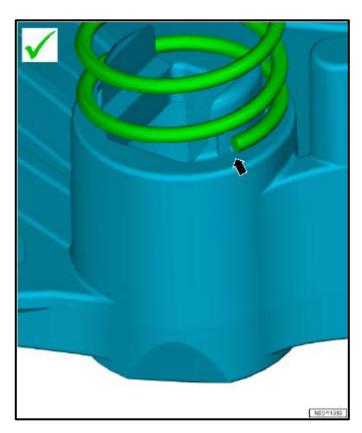
Spring seated correctly <arrow>.

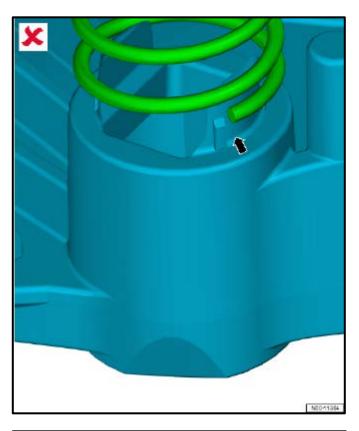
- If one of the springs is damaged or has been lost, it can be replaced with a spring from the bag of spares included.
- Note the examples shown for reference of proper spring seating.
- Spring seated incorrectly <arrow>.

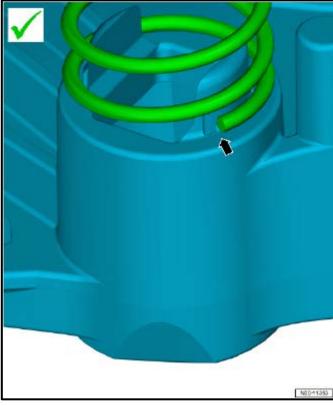
Spring seated correctly <arrow>.
