September 2018  
FL768AB  
NHTSA #18V-250 School Buses  
#18V-378 Non-School Buses  
Transport Canada #18-197

**Subject: FCCC Bus Chassis Battery Cable Interference**

**Models Affected: Freightliner Custom Chassis B2 school bus chassis (Thomas Built Buses Saf-T-Liner C2) and S2C shuttle bus chassis manufactured March 10, 2017, through March 6, 2018.**

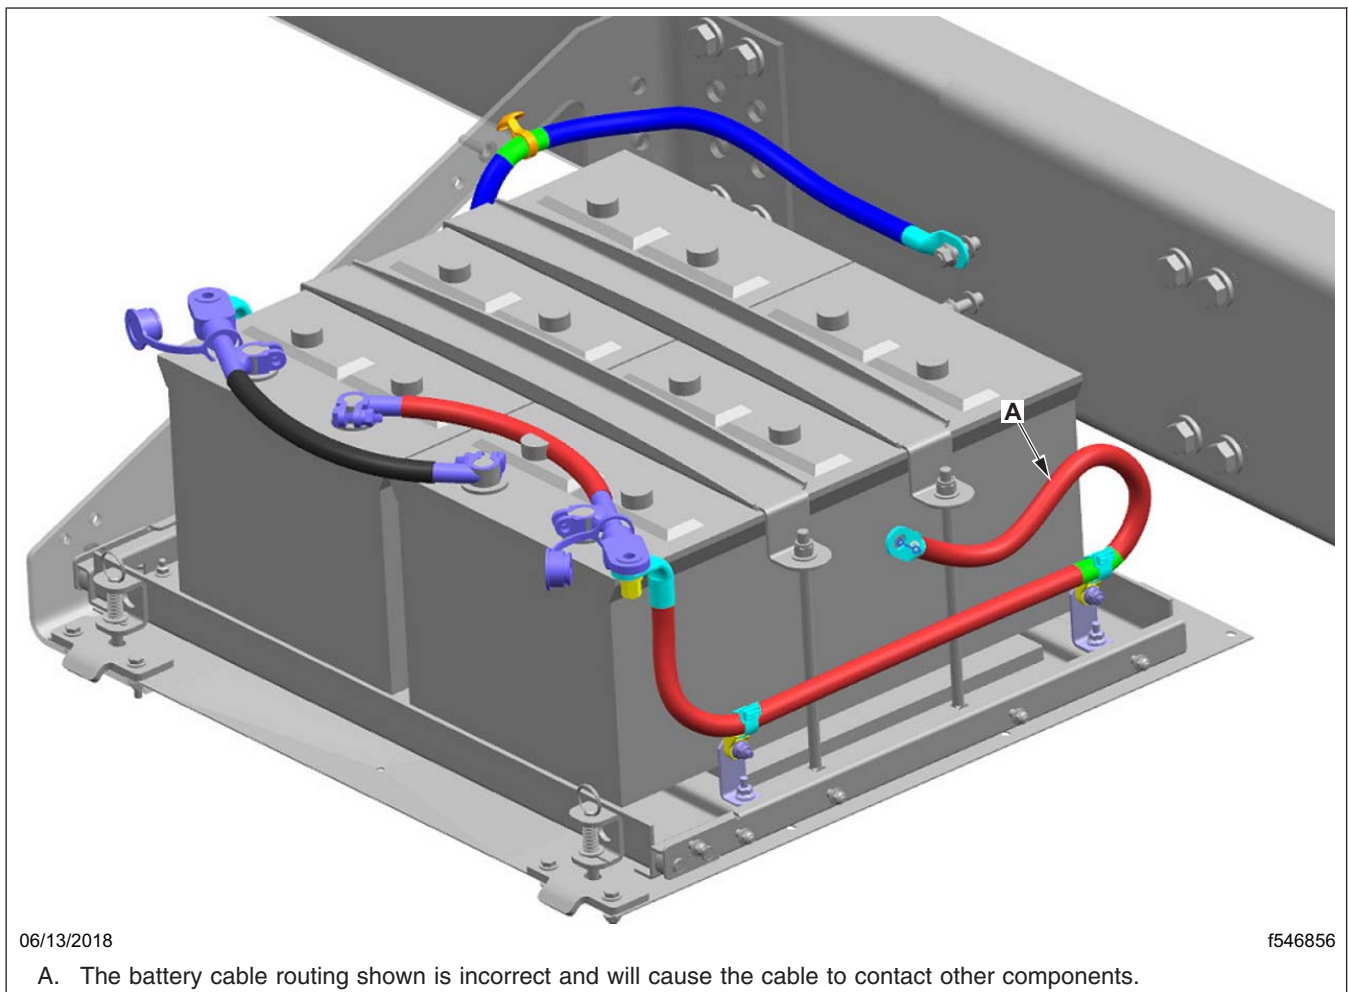
**Fig. 1, Incorrect Battery Cable Installation**

On certain vehicles, a battery power cable may be routed with inadequate clearance between the cable and a battery hold down bracket. This reduced clearance may cause the cable to rub against the hold down bracket, potentially damaging the cable and leading to arcing, which may increase the risk of a fire.

1. Check the base label (Form WAR259) for a completion sticker for FL768 (Form WAR260) indicating this work has been done. For school buses, the base label is usually located above the driver's window. For shuttle buses, it's usually located in the driver's area. If a sticker is present, no work is needed. If there is no sticker, proceed with the next step.
2. Park the vehicle on a level surface, shut down the engine, and set the parking brake. Chock the tires.
3. Inspect the battery cable for correct orientation. There must be a minimum of ½ inch (13 mm) between the cable and the battery hold-down bracket and stud when sliding the battery tray in and out. **Fig. 1** shows an incorrect battery cable installation. **Fig. 2** shows the correct battery cable installation.

- 3.1 If the battery cable is installed correctly, no further work is needed. Go to step 7.
- 3.2 If the battery cable is not installed correctly, inspect the cable for damage. It is possible for the conduit that covers the battery cable to be damaged, but the battery cables themselves are not damaged. Damage to the battery cables could include, but is not limited to, a cut in the battery cable or visible cable insulation. If the **battery cable** is damaged, go to 'Battery Cable Replacement.' If the cable is not damaged, but requires proper orientation, go to the next step.

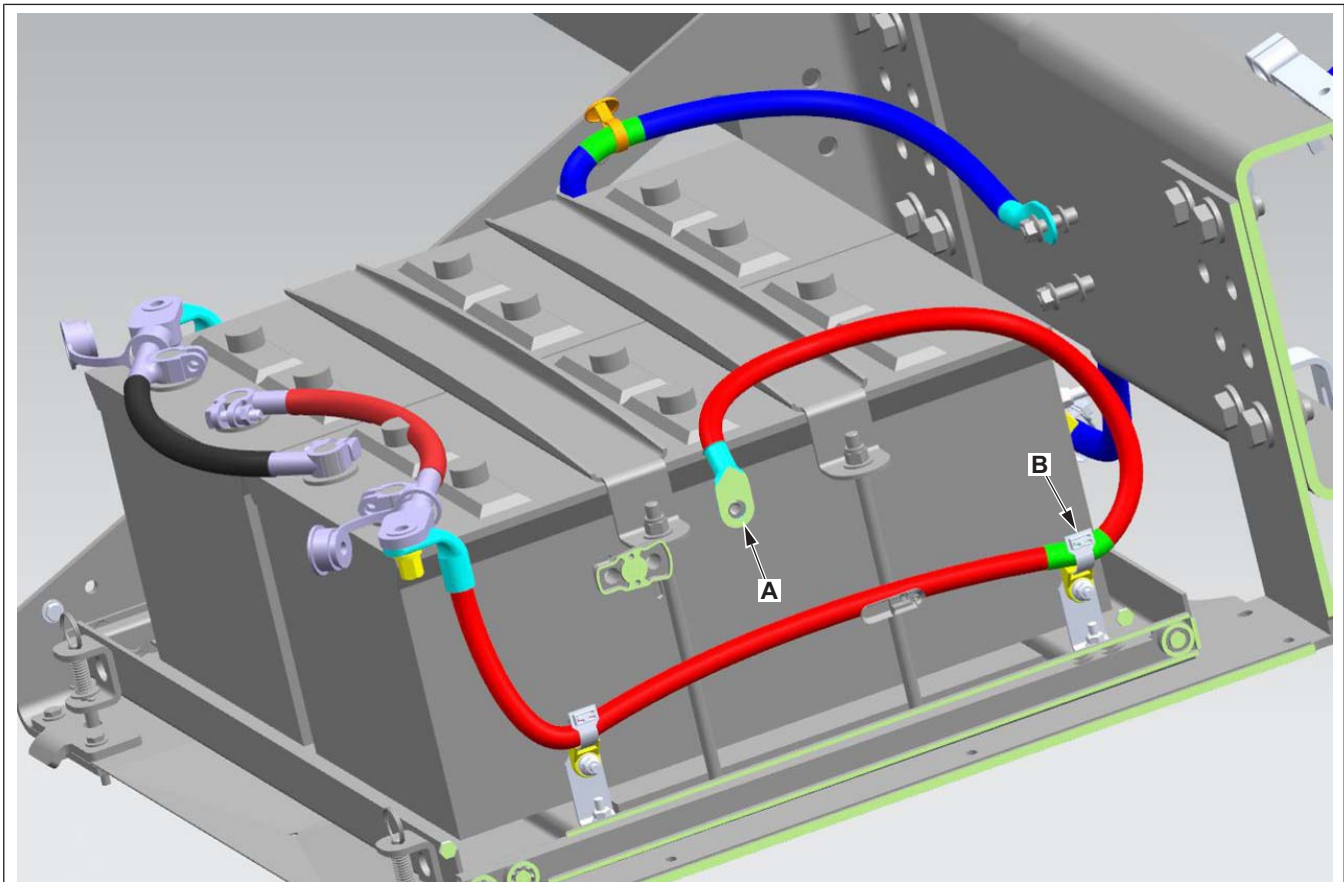
**Fig. 2, Correct Battery Cable Installation**

- A. Rotate the end of the battery cable to an approximate 11 o'clock position.
- B. Align the tape on the battery cable with the saddle mount.

4. With the battery tray pushed in, use a wrench to loosen the nut on the battery cable at the power distribution module (PDM) stud.
5. Rotate the end of the battery cable as shown in **Fig. 2**, then tighten the nut 26 lbf-ft (35 N-m).

6. Slide the battery tray in and out to verify the battery cable does not rub the battery hold-down bracket or stud.
7. Clean a spot on the base label (Form WAR259). Write the recall number, FL768, on a blank red completion sticker (Form WAR260), and attach it to the base label to indicate this recall has been completed.

4. With the battery tray pushed in, loosely install the new battery cable on the PDM stud with the nut removed earlier. Route the cable back toward the frame rail, then loop it forward, aligning the tape on the cable with the saddle mount as shown in [Fig. 2, ref. B](#). Rotate the end of the cable to the 11 o'clock position (approximately), ensuring there is ½ inch (13 mm) clearance between the battery cable and the battery hold-down bracket and stud. Tighten the nut 26 lbf·ft (35 N·m).
