Intermittent Air Gauge Operation

RECALL

Models Affected: Certain 2018 - 2019 Model Year Vision and All American Air Brake Buses

R18ZE - Intermittent Air Gauge Operation

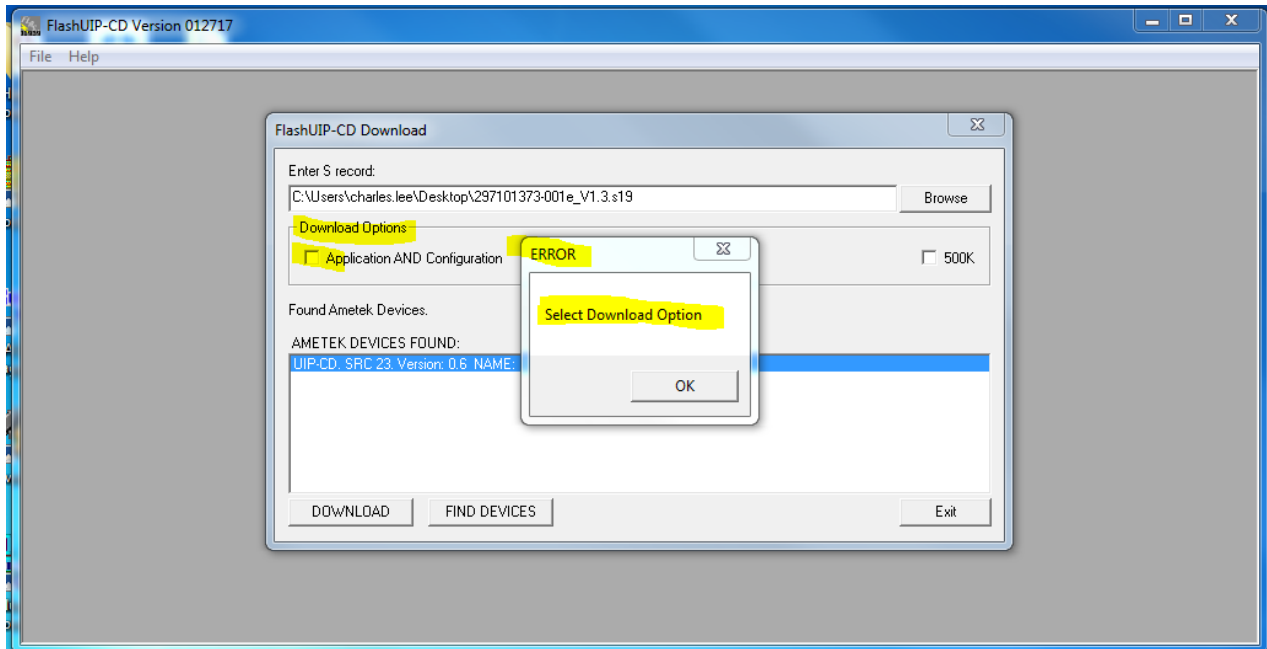
ERROR 'Select Download Option'

The 'Application AND Configuration' box was NOT checked before clicking the "DOWNLOAD" button.

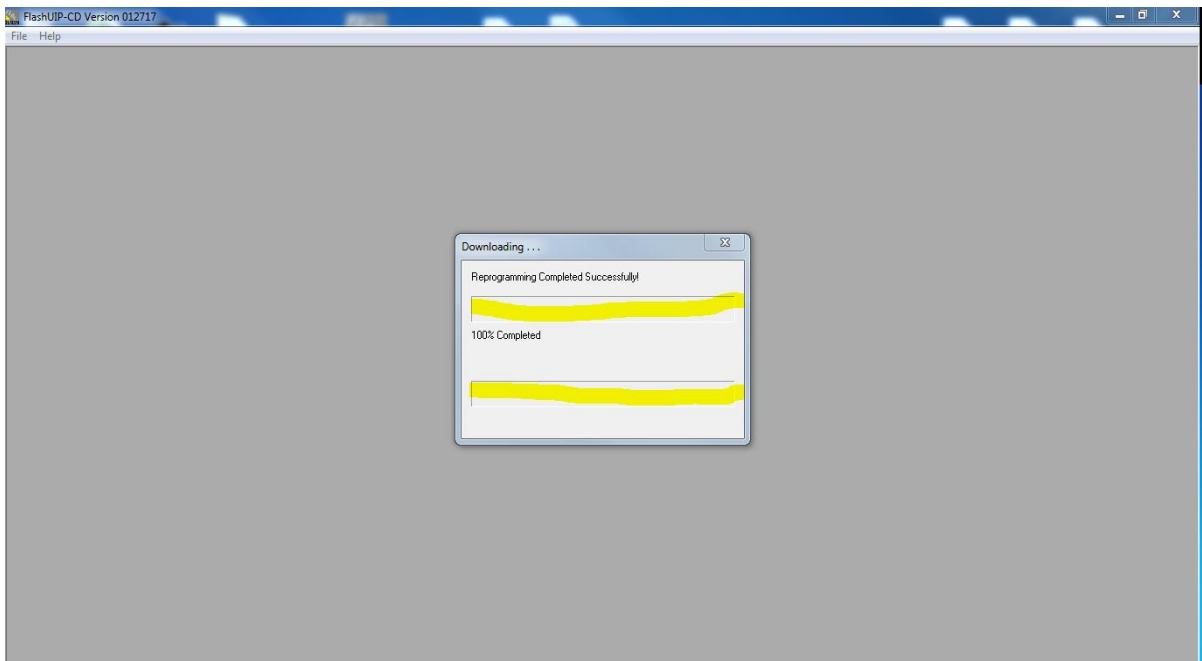
'Both status bars are blank'

The incorrect file type was selected. Insure the file type selected is '.s19'

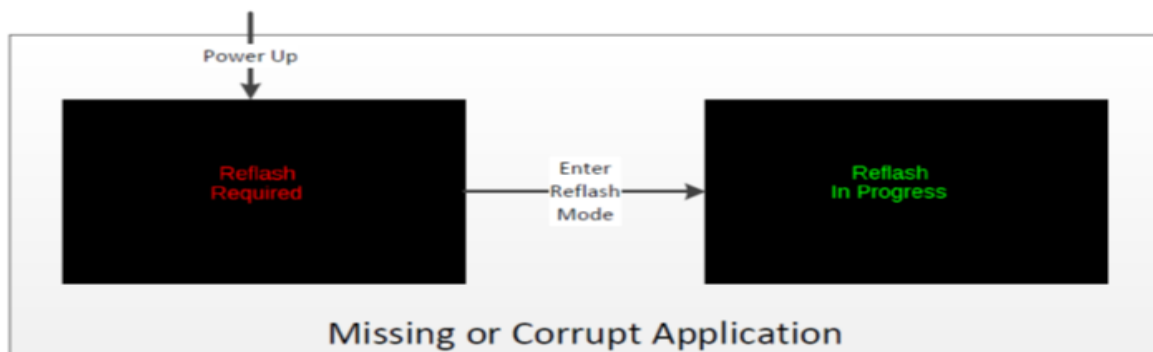
'Reflash Required'

Instrument cluster software files were erased and updated process was not successful. Possible causes include loss of power, ground, or J1939, during software update. Check J1939, battery, ignition, and ground connections at the cluster and the diagnostic port connector.
