May 2018

Dealer Service Instructions for:

Safety Recall U42 / NHTSA 18V-279 Front Lower Control Arms

2018 (MP) Jeep® Compass

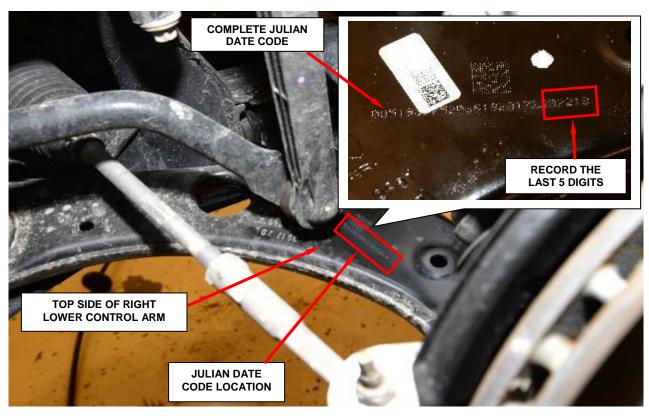
The front lower control arms on about 2,700 of the above vehicles may have been built with out-of-specification welds potentially resulting in a control arm separation. A front lower control arm separation may cause a reduction in vehicle control and can cause a vehicle crash without prior warning.

- 1. Raise and support the vehicle.
- 2. Remove the right front tire and wheel assembly.
- 3. Locate the right front control arm Julian date code etching and record last 5 digits for use in Step 5 (Figure 1).

NOTE: The Julian date code etching for the <u>right front control arm</u> is located on the <u>top side</u> of the control arm.

4. Locate the left front control arm Julian date code etching and record last 5 digits for use in Step 5 (Figure 1).

NOTE: The Julian date code etching for the <u>left front control arm</u> is located on the <u>bottom side</u> of the control arm.

Figure 1 – Right Side Julian Date Code Shown (record last 5 digits of etching number) Left Side Similar (Located on the Bottom of the Control Arm)

- 5. Are the last 5 digits of the Julian date code **00818**?
 - ➢ No, the lower control arm is good. Replacement not needed. If both control arms are good, continue with Step 6.
 - Yes, replace lower control arm(s) that have a Julian date code of 00818, continue with section B. Replace Front Lower Control Arm(s).
 - If the Julian date code is not visible continue with section B. Replace Front Lower Control Arm(s).
- 6. Install the right front tire and wheel assembly and tighten the wheel lugs/nuts to $135 \text{ N} \cdot \text{m}$ (100 ft. lbs.).
- 7. Lower the vehicle.
- 8. Return the vehicle to the customer.
