**NHTSA#** Jayco 18V-292  
Starcraft 18V-294

**Date of Publication:** June 2018

**Recall  
Remedy**

### INSTRUCTIONS – Installation of the Stop Plate – ONLY 2011-2013 Camping Trailers manufactured prior to OCTOBER 2012 with a Power Roof Lift System.

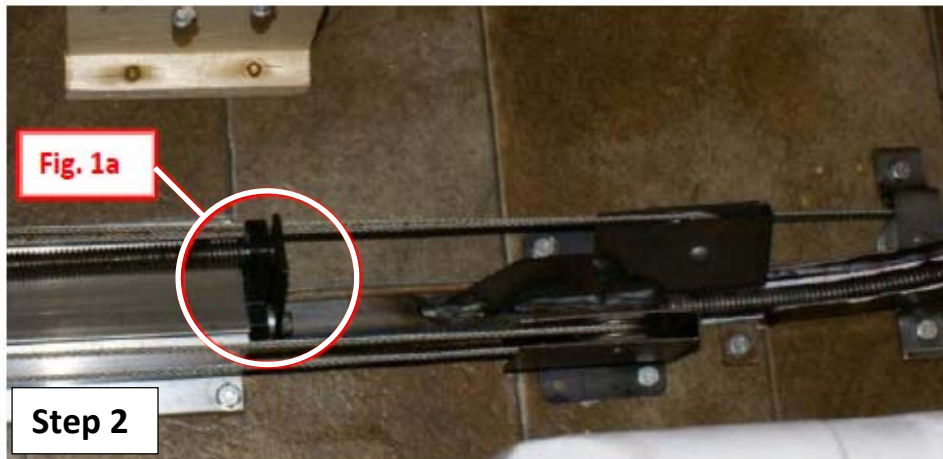
End Piece

2. Once you have gained access, locate the lifter system actuator (end piece) **(Fig 1A)**
