Safety Recall

Code: 40N4

Subject	Lower Ball Joint Nuts
Release Date	May 25, 2018
Affected Vehicles	U.S.A. & CANADA: Certain 2018 MY Tiguan <i>Check Campaigns/Actions screen in Elsa on the day of repair to verify that a VIN qualifies for repair under this action. Elsa is the <u>only</u> valid campaign inquiry & verification source.</i> <ul style="list-style-type: none">✓ Campaign status must show "open."✓ If Elsa shows other open action(s), inform your customer so that the work can also be completed at the same time the vehicle is in the workshop for this campaign.
Problem Description	The nut holding the lower ball joint of the front wheel in each side may be loose or improperly torqued. A loose or improperly torqued ball joint nut can result in dislocation of the lower ball joint. This may cause steering, traction or other stability issues relating to the front wheels and potentially result in a crash.
Corrective Action	Replace the nut of the lower ball joint (ball joint to wheel bearing housing) on both sides of each affected vehicle.

Safety Recall 40N4 – Lower Ball Joint Nuts

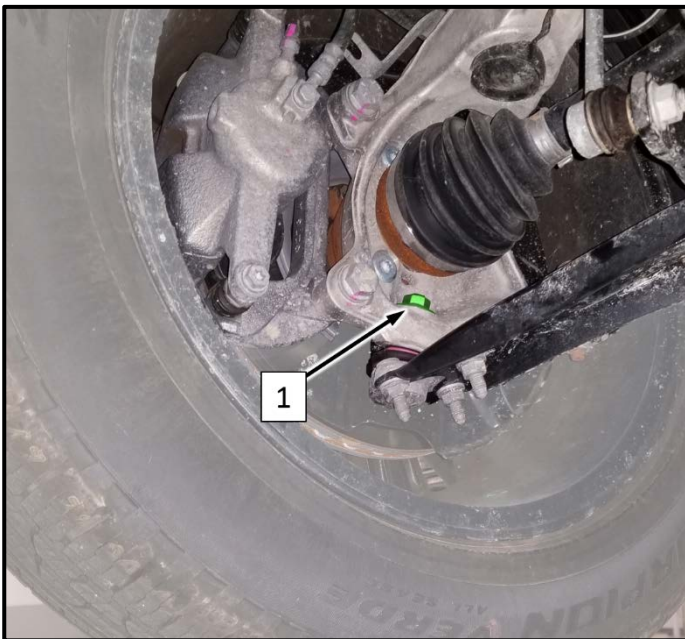
Recall Description: The nut holding the lower ball joint of the front wheel in each side may be loose or improperly torqued. A loose or improperly torqued ball joint nut can result in dislocation of the lower ball joint. This may cause steering, traction or other stability issues relating to the front wheels and increase the risk of a crash.

Both ball joint nuts will be replaced (Right side shown in picture).

- Turn the wheels all the way to the left or right.
- Remove the ignition key so the steering column locks.
- Raise the vehicle.
- Remove nut <1> and clean the threads on the ball joint stud.

Ensure the tool used to torque nut <1> is not jammed against the wheel bearing housing when torquing.

- Counter hold ball joint stud and torque new nut <1> to 70 Nm using the -VAG1332- and -VAG1332/10- or an equivalent torque wrench and 18 mm crowsfoot.

A tool with a T-30 Torx bit and a max dimension <A> of 17mm can be used to counter hold the ball joint stud.
