Safety Recall

Code: 40N4

Subject	Lower Ball Joint Nuts
Release Date	February 19, 2020
Revision Summary	Ten (10) VINs (9 in U.S. and one in Canada) added under criteria 03. Claiming instructions updated.
Affected Vehicles	U.S.A. & CANADA: Certain 2018 MY Tiguan <i>Check Campaigns/Actions screen in Elsa on the day of repair to verify that a VIN qualifies for repair under this action. Elsa is the <u>only</u> valid campaign inquiry & verification source.</i> <ul style="list-style-type: none">✓ Campaign status must show "open."✓ If Elsa shows other open action(s), inform your customer so that the work can also be completed at the same time the vehicle is in the workshop for this campaign.
Problem Description	The nut holding the lower ball joint of the front wheel in each side may be loose or improperly torqued. A loose or improperly torqued ball joint nut can result in dislocation of the lower ball joint. This may cause steering, traction or other stability issues relating to the front wheels and potentially result in a crash.

Safety Recall 40N4 – Lower Ball Joint Nuts

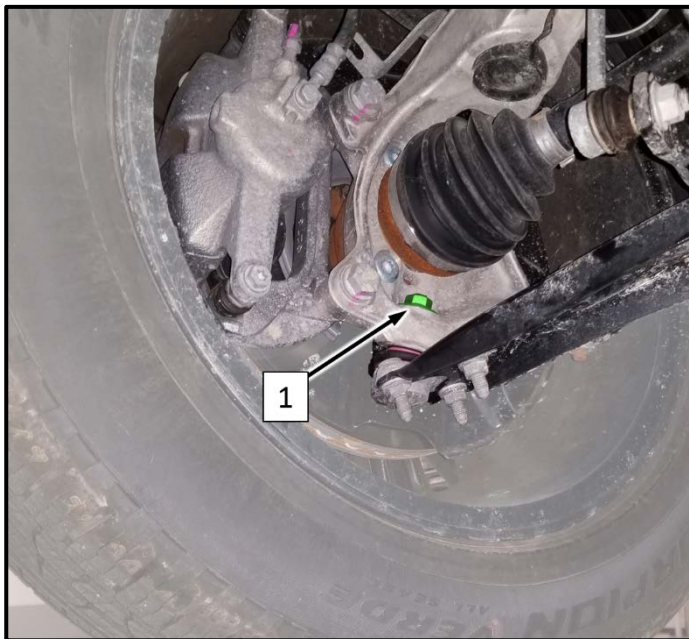
Recall Description: The nut holding the lower ball joint of the front wheel in each side may be loose or improperly torqued. A loose or improperly torqued ball joint nut can result in dislocation of the lower ball joint. This may cause steering, traction or other stability issues relating to the front wheels and increase the risk of a crash.

Both ball joint nuts will be replaced (Right side shown in picture).

- Turn the wheels all the way to the left or right.
- Remove the ignition key so the steering column locks.
- Raise the vehicle.
- Remove nut <1> and clean the threads on the ball joint stud.

Ensure the tool used to torque nut <1> is not jammed against the wheel bearing housing when torquing.

- Counter hold ball joint stud and torque new nut <1> to 70 Nm using the -VAG1332- and -VAG1332/10- or an equivalent torque wrench and 18 mm crowsfoot.
