Safety Recall

Code: 40N4/40N5

Subject	Lower Ball Joint Nuts
Release Date	June 22, 2018
Revision Summary	Recall information & repair instructions added for vehicles in Safety Recall 40N5 IMPORTANT: Affected vehicles will have ONLY one recall code open (either 40N4 OR 40N5). Vehicles will <u>NOT</u> have both codes open.
Affected Vehicles	U.S.A. & CANADA: Certain 2018 MY Tiguan <i>Check Campaigns/Actions screen in Elsa on the day of repair to verify that a VIN qualifies for repair under this action. Elsa is the <u>only</u> valid campaign inquiry & verification source.</i> <ul style="list-style-type: none">✓ Campaign status must show "open."✓ If Elsa shows other open action(s), inform your customer so that the work can also be completed at the same time the vehicle is in the workshop for this campaign.
Problem Description	The nut holding the lower ball joint of the front wheel in each side may be loose or improperly torqued. A loose or improperly torqued ball joint nut can result in dislocation of the lower ball joint. This may cause steering, traction or other stability issues relating to the front wheels and potentially result in a crash.

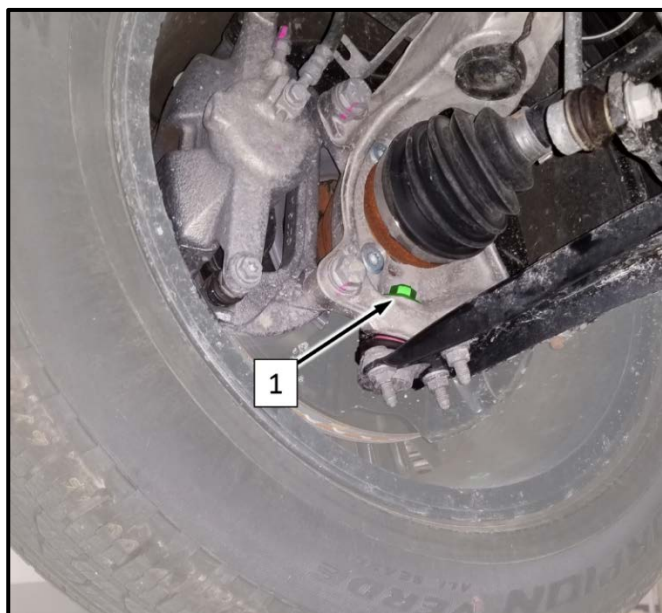
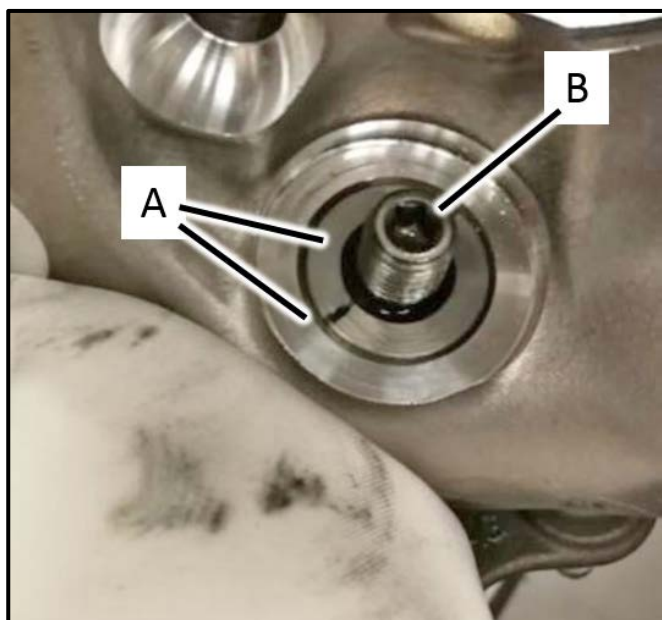
40N4 - Both ball joint nuts will be replaced (Right side shown in picture). **40N5** – One or both ball joint nuts will be replaced (depending on criteria).

- Turn the wheels all the way to the left or right.
- Remove the ignition key so the steering column locks.
- Raise the vehicle.
- Remove nut <1>.

- Clean contact surface <A> and threads of ball joint stud using a cloth that leaves no residue.

- Counter hold ball joint stud and torque new nut <1> to 70 Nm using the -VAG1332- and -VAG1332/10- or an equivalent torque wrench and 18 mm crowsfoot.

Ensure the tool used to torque nut <1> is not jammed against the wheel bearing housing when torquing.
